**Re: *W. Va. Code §22-6A-23 Impoundment and Pit Safety Study***

### **INTRODUCTION**

### **ETD-10 Pits and Impoundments Evaluation Report Site Observations / Comments**

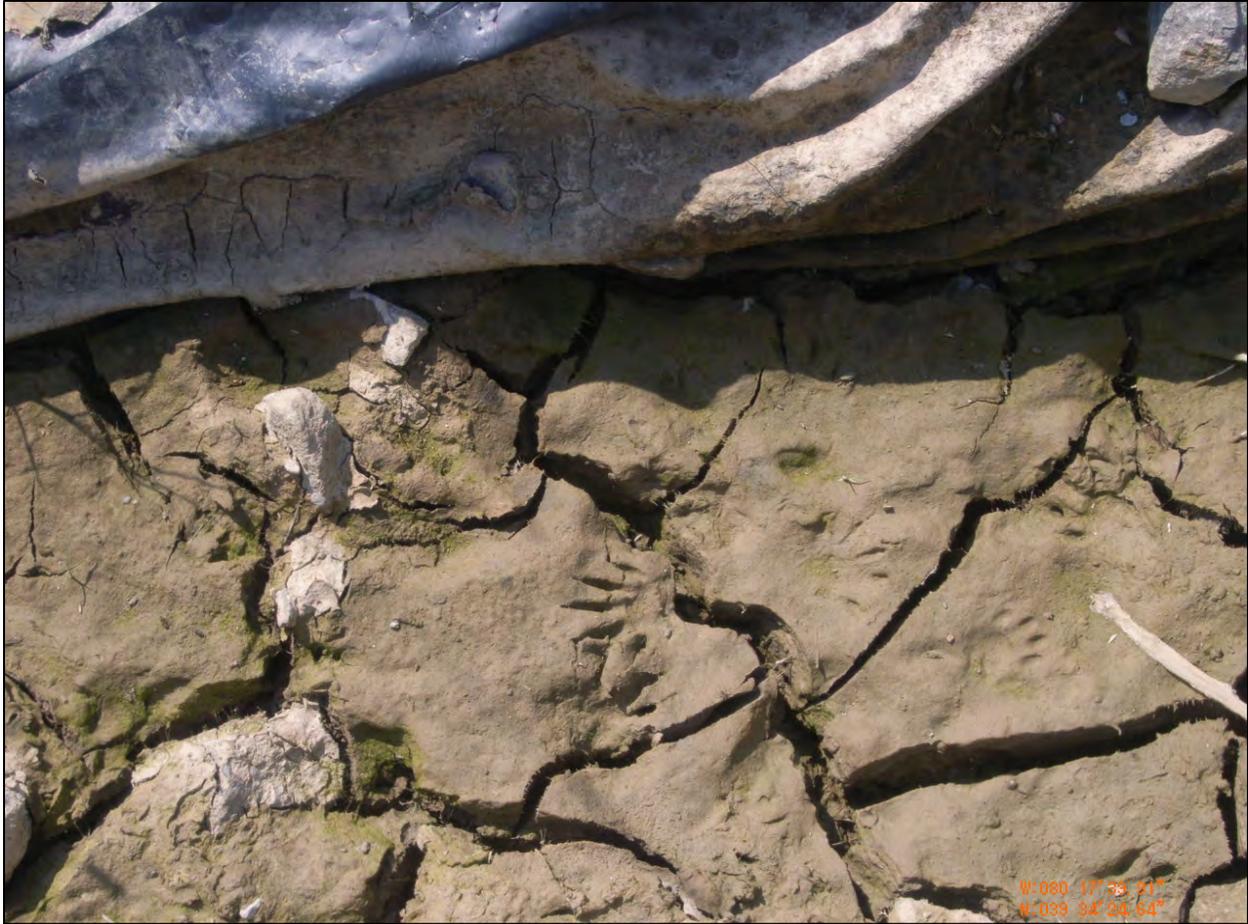
**Figure 4: Settlement Cracks in Anchor Trench**

Figure 4 shows settlement cracks on the crest of the impoundment around the anchor trench. The significance of this observation is that these cracks can serve as pathways for water to infiltrate and saturate the soil. The wet soil adds weight to the top of the slopes and is a recognized mechanism for surface water infiltration leading to slope instability.

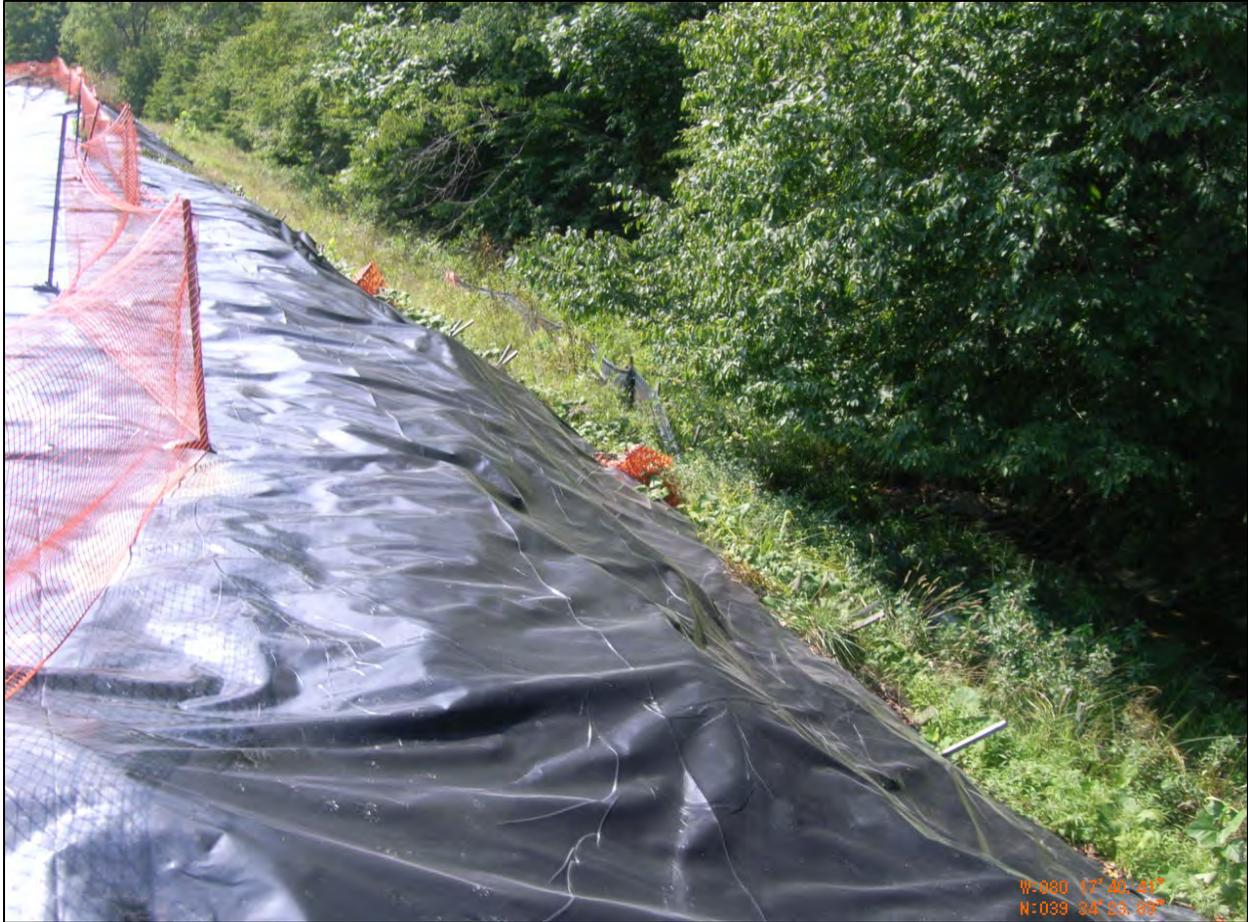
**Figure 5: Bulges on Downstream Face**

In Figure 5, the bulges underneath the liner indicate slope movements on the downstream face. The slope movements are evidence that the slope is no longer stable and that the ability for the structure to retain fluid has been compromised.

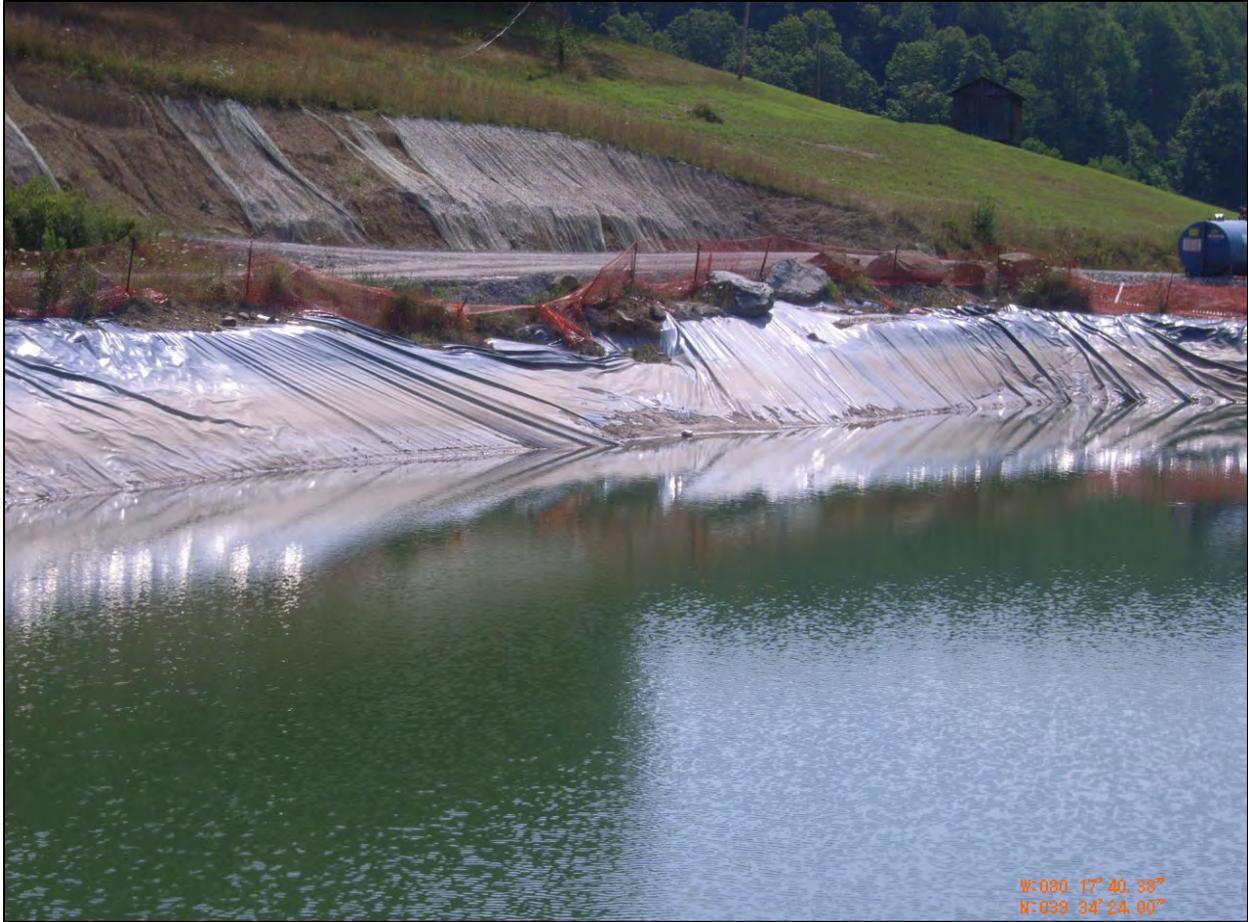
**Figure 6: Slope Movement into Impoundment**

Figure 6 depicts a slide into the impoundment. This slide is putting strain on the liner, endangering the anchor trench and increasing the tear potential for the liner. Additionally, the slide is just below the site access road and is thereby threatening the integrity of the roadway. The displacement of the liner threatens the entire containment system due to an increased potential for tears or punctures leading to impounding water loss.

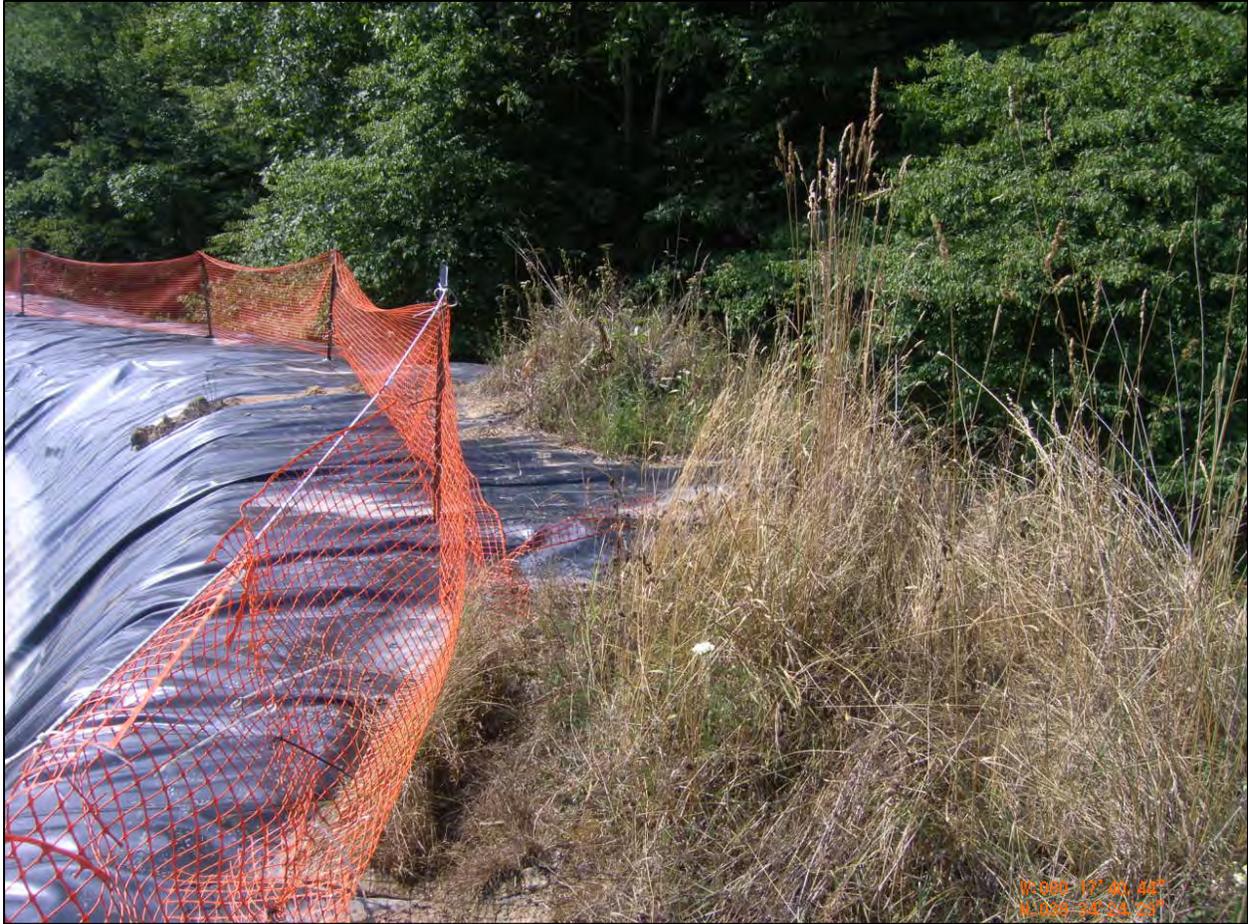
**Figure 7: Vegetation on Berm**

The vegetation shown in Figure 7 poses a problem for inspection procedures. The excessive vegetative growth on the crest may conceal potential areas of concern. Thus, corrective actions may not be implemented at an appropriate time.

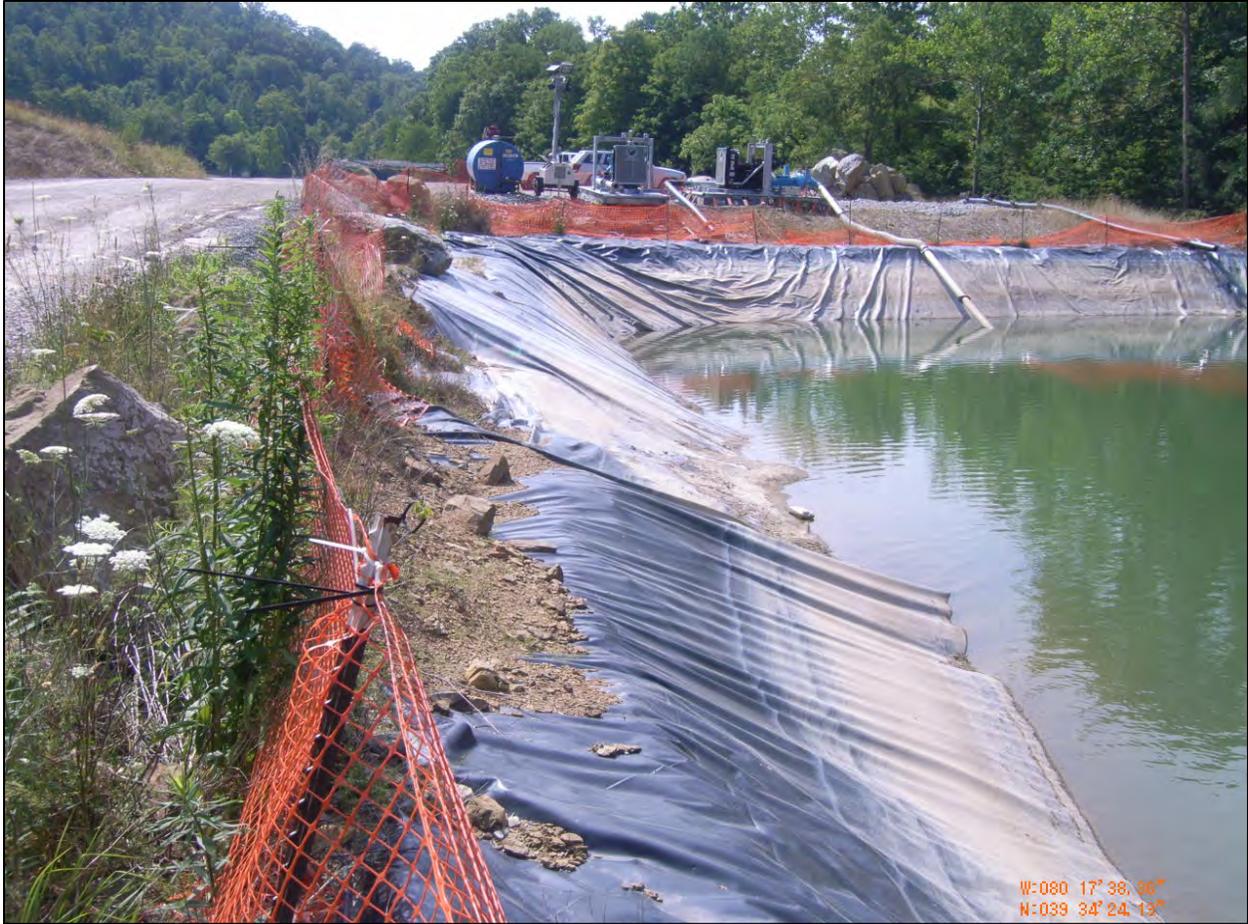
**Figure 8: Rock and Debris on Liner**

In Figure 8, a high amount of soil and rock is present on the liner, including a large boulder in danger of sliding into the impoundment or puncturing the liner. A possible consequence related to this problem is that the rock and debris add weight to the liner, straining the embedment of the anchor trench and posing a hazard to the containment system.

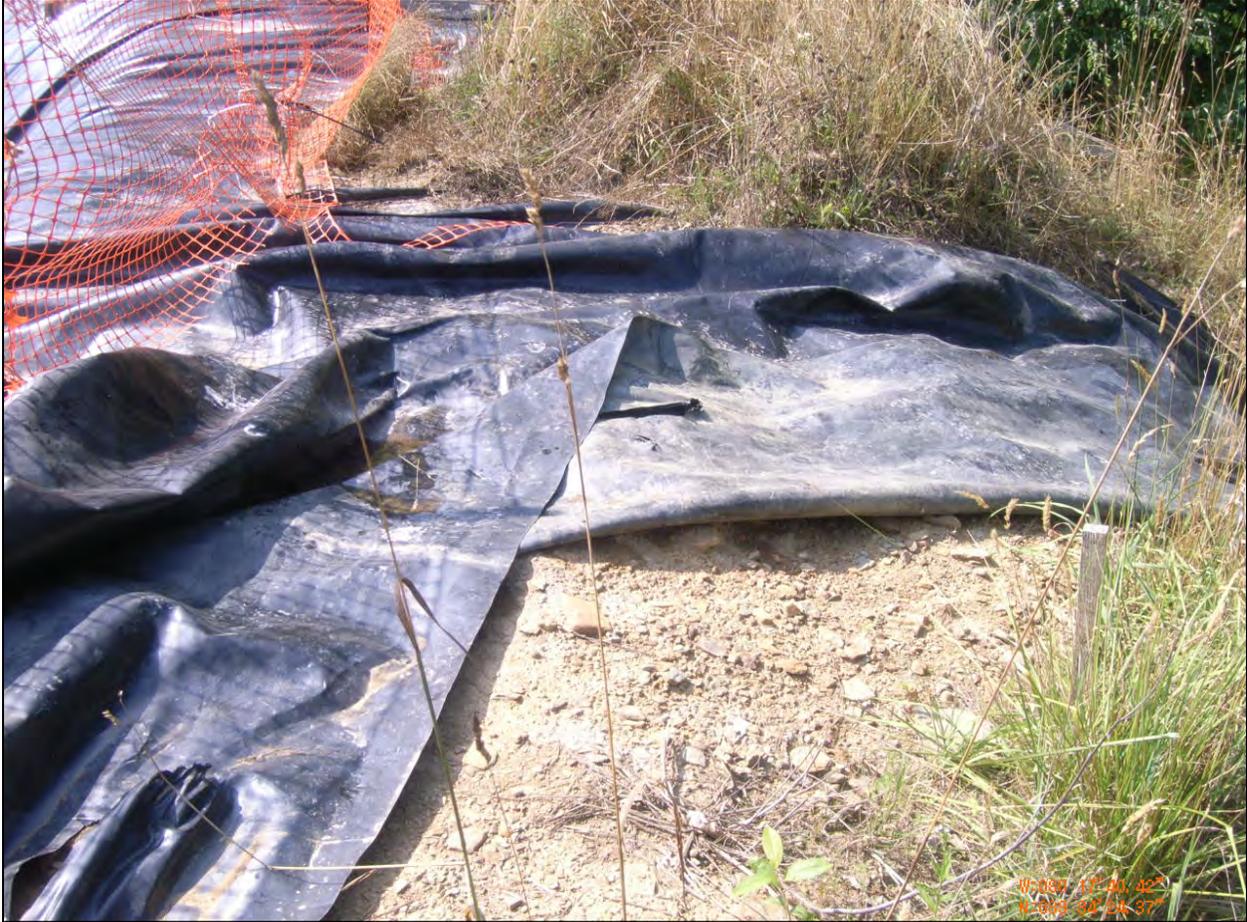
**Figure 9: Anchor Trench Exposed**

Figure 9 illustrates an improper anchor trench for the liner. With the liner exposed, the potential for wind uplift is greatly increased, which could lead to displacement of the liner and possible failure of the containment system.

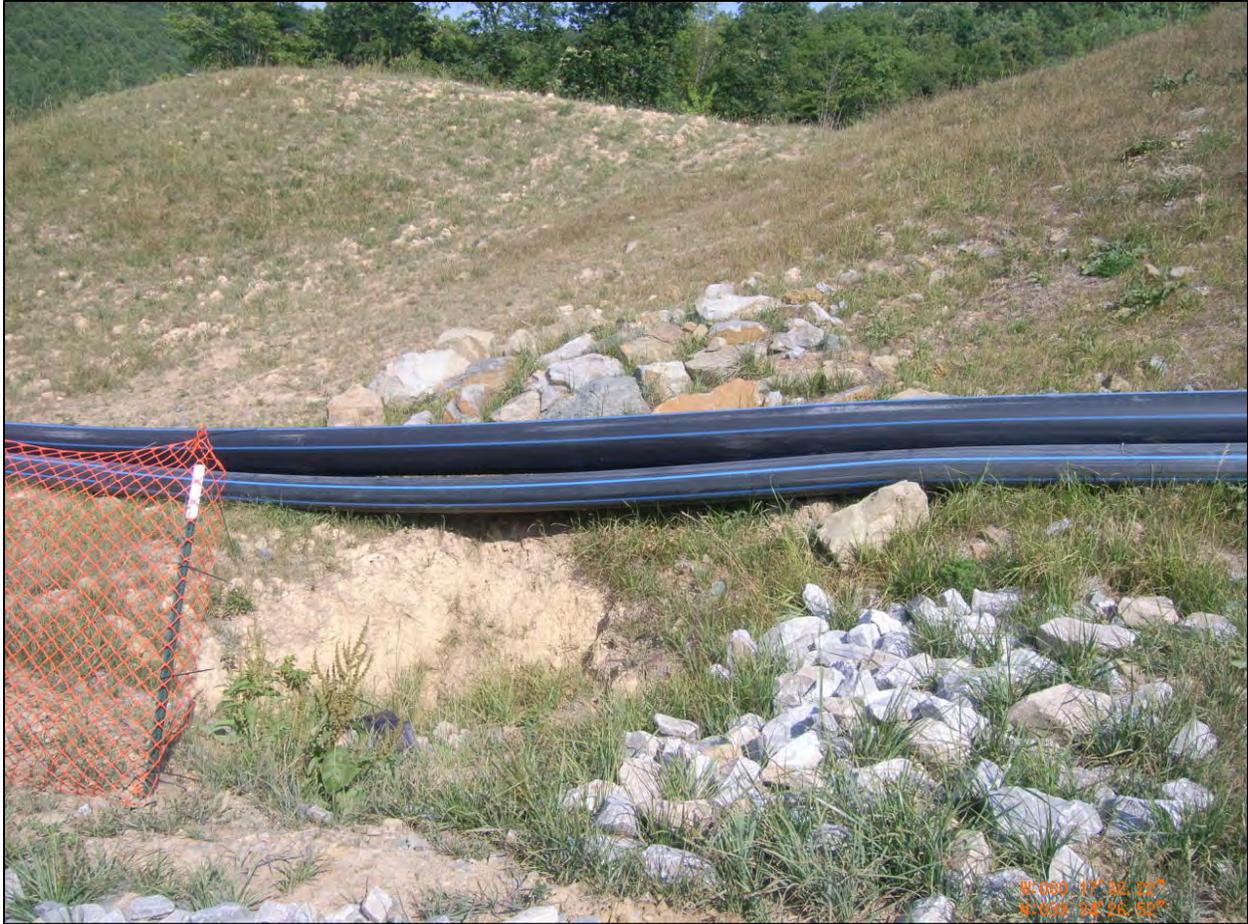
**Figure 10: Unsupported Pipe**

Figure 10 shows unsupported pipes along the hillside above the access road. Due to this placement, there is a greater likelihood of damage to the pipes that may lead to leakage and uncontrolled release of liquids. Any leakage or rupture of the pipes which convey water or flowback fluids would have an environmental impact to the surface water and groundwater.

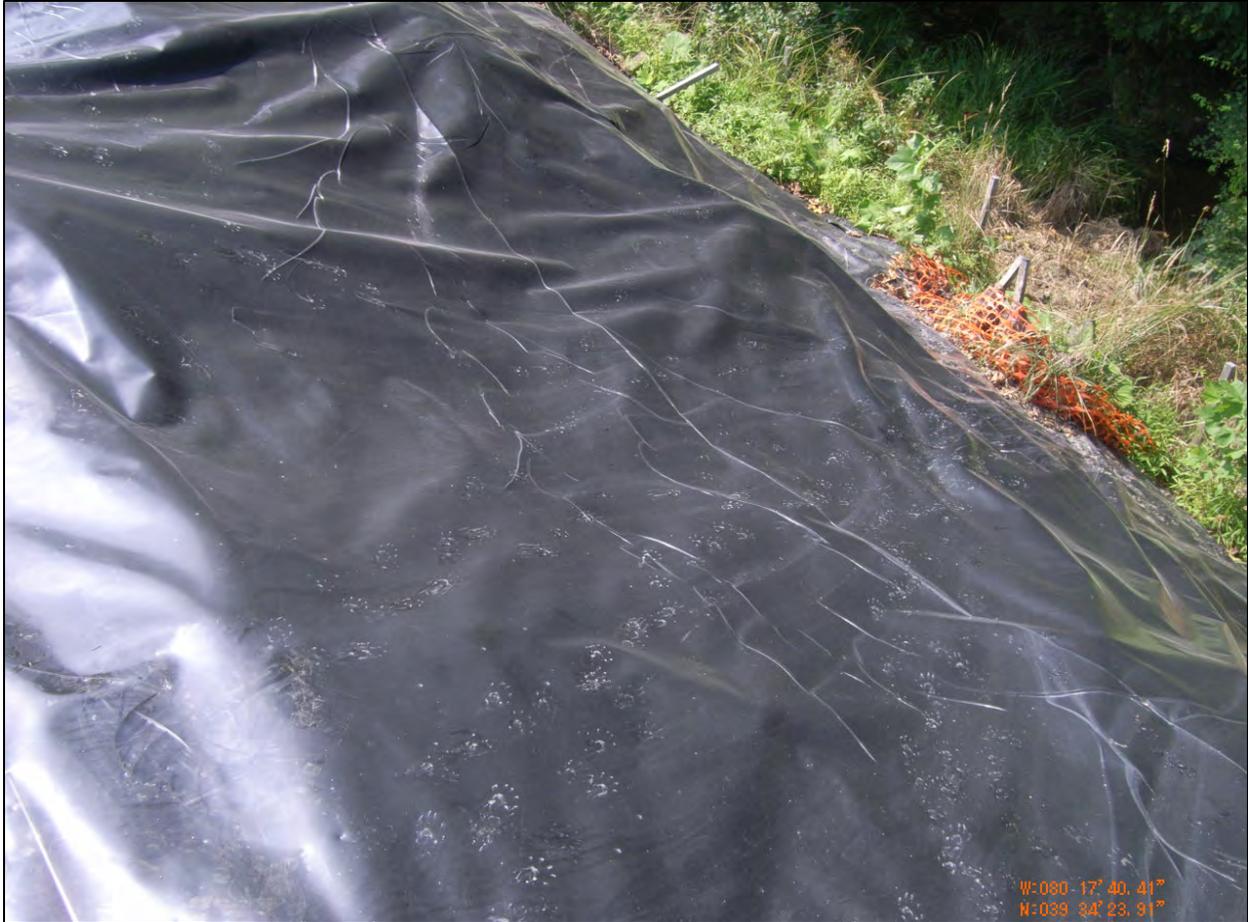
**Figure 11: Downstream Slope Movement into Ditch**

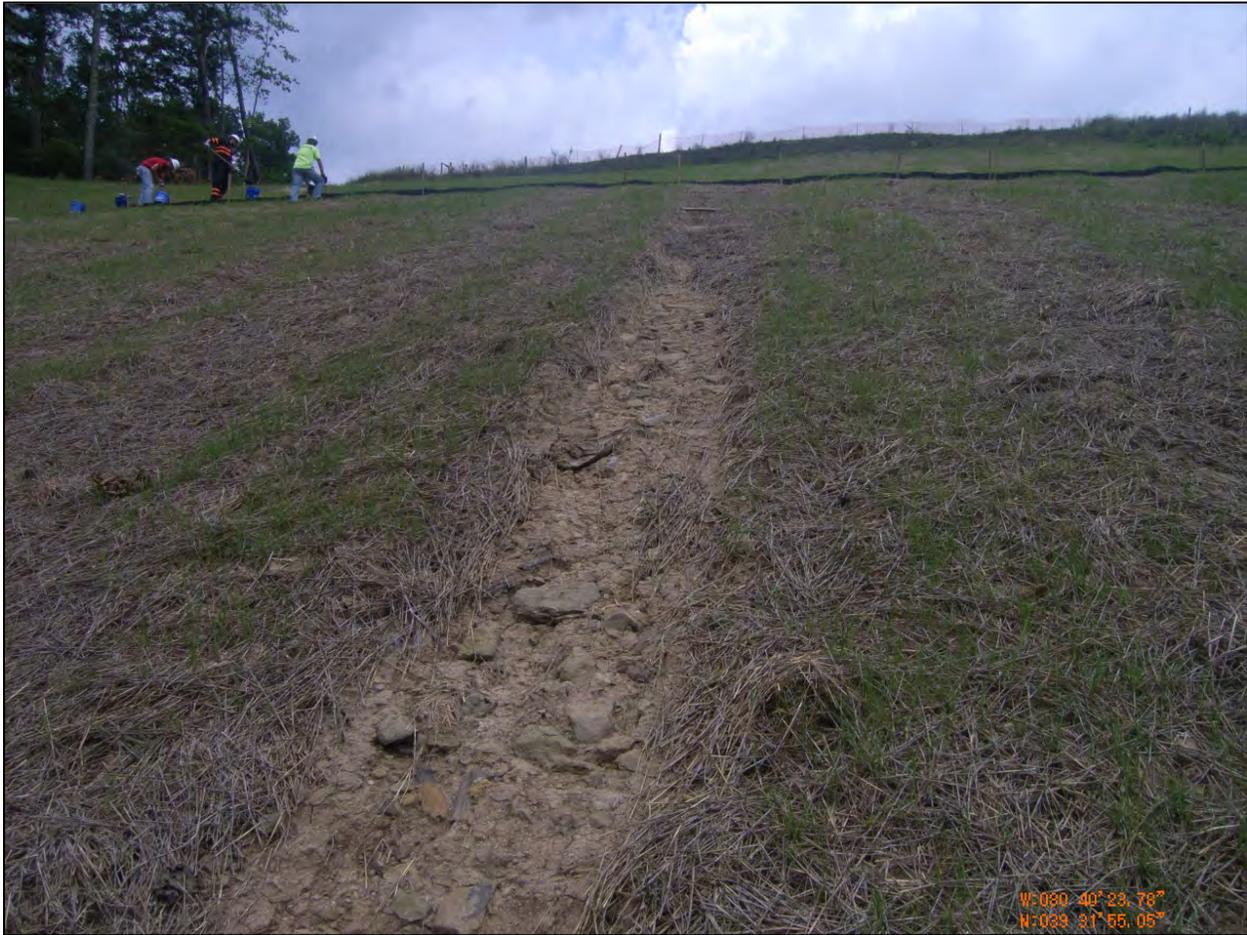
**Figure 12: Surface Erosion at Mills-Wetzel**

One problem area observed at all sites was surface erosion, found in Question 1 on the observation checklist. This problem was the most observed and, hence, received the lowest average ranking of 2.00. Figure 12 shows an example of the surface erosion present at the Mills-Wetzel Freshwater Impoundment. The gully shown formed rapidly, as evidenced by the lack of vegetation. The formation of the gully may be a result of excessive slope length or angle on the downstream face. The West Virginia Erosion and Sediment Control Field Manual states that terracing shall be constructed for each additional 50 vertical feet of slope and shall be a minimum of 10 feet wide. This best management practice was not followed on the Mills-Wetzel site.

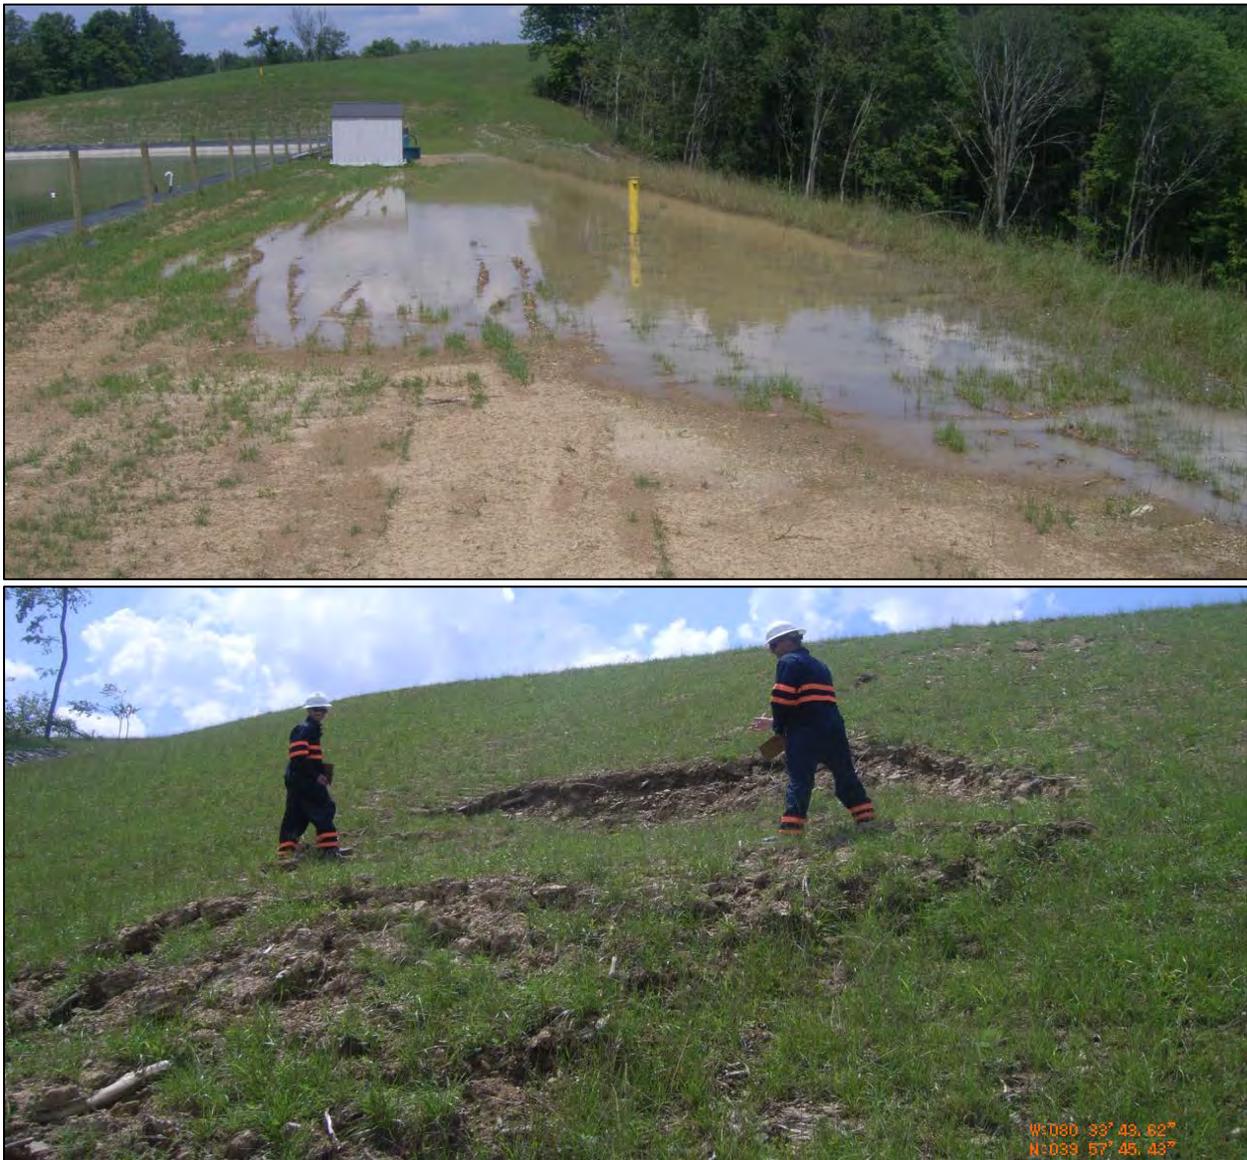
**Figure 13: Slope Movement at SHL 4**

Question 2 on the checklist related to the prevalence of slope movements on the downstream face. Two sites were found to have moderate slope movements, and severe slope movements were present on six sites. Figure 13 shows a severe slope movement on the SHL 4 Centralized Pit. Above the slope movement, there was a significant amount of standing water on the crest, and signs of seepage were found in the form of wet soil inside the depleted soil zone. Slope movements are a problem because the structural integrity of the downstream face has been compromised. This slope failure is an example of a shallow face failure with characteristics including a pronounced scarp, zones of depletion and accumulation, and flanks defining the width of the failed soil, which is approximately where the WVU field personnel are located.

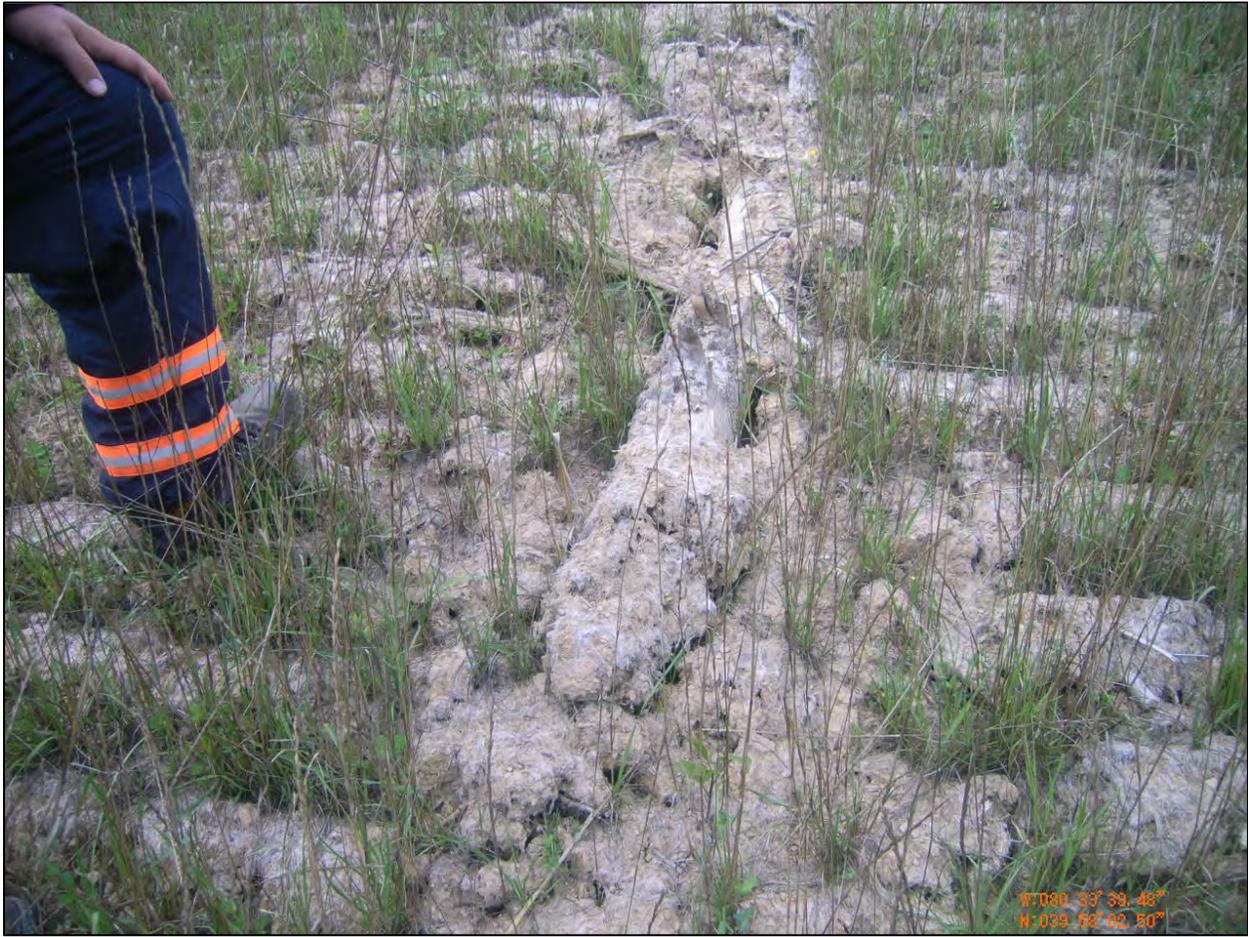
**Figure 14: Woody Debris at SHL 2**

Question 5 was used to evaluate any observed trees, tall weeds, or other vegetation, but the most prevalent concern was woody debris found in the fill of the slopes on all but two sites. Figure 14 depicts one instance of woody debris found on the SHL 2 Centralized Pit, where a log was compacted into the fill material on the downstream face of the pit. Woody debris is a problem due to the complications that may arise over time. One possible consequence is that the woody debris may form a barrier preventing the infiltration of water into the soil, causing erosion around the woody debris and on the slope directly below the debris. Another possible consequence is that the decomposition of the woody debris may result in pathways for surface water to seep into the slope, which reduces slope stability.

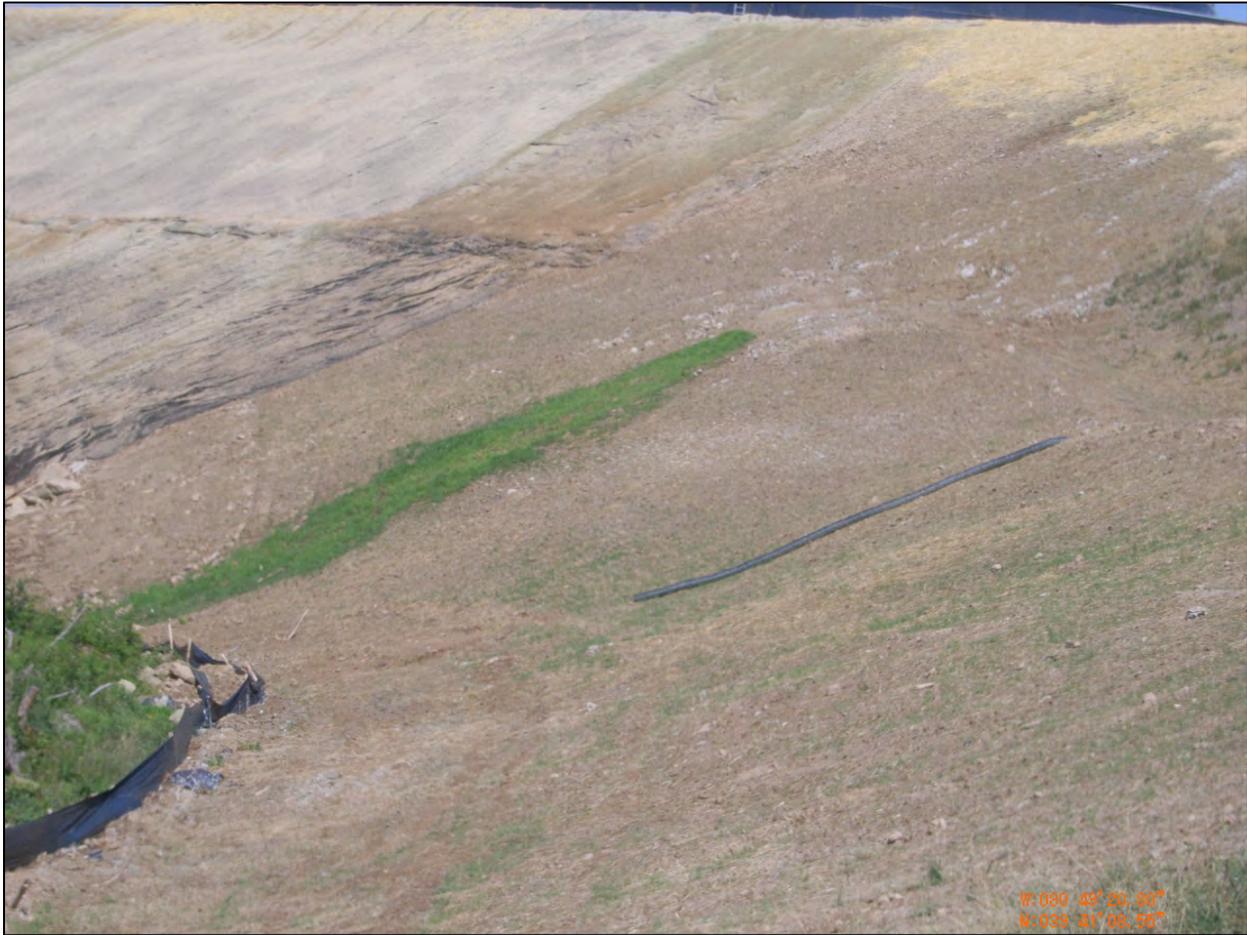
**Figure 15: Seepage at Pribble**

Seepage and wet zones (addressed in Question 6) were problem areas found at all but two sites. Figure 15 shows a seepage area on the downstream face of the Pribble Freshwater Impoundment. Due to the lack of vegetation on the slope, the area where the grass is growing depicts seepage and moving water on the slope. Thus, water is being transported through the soil, which may lead to instability in this area.

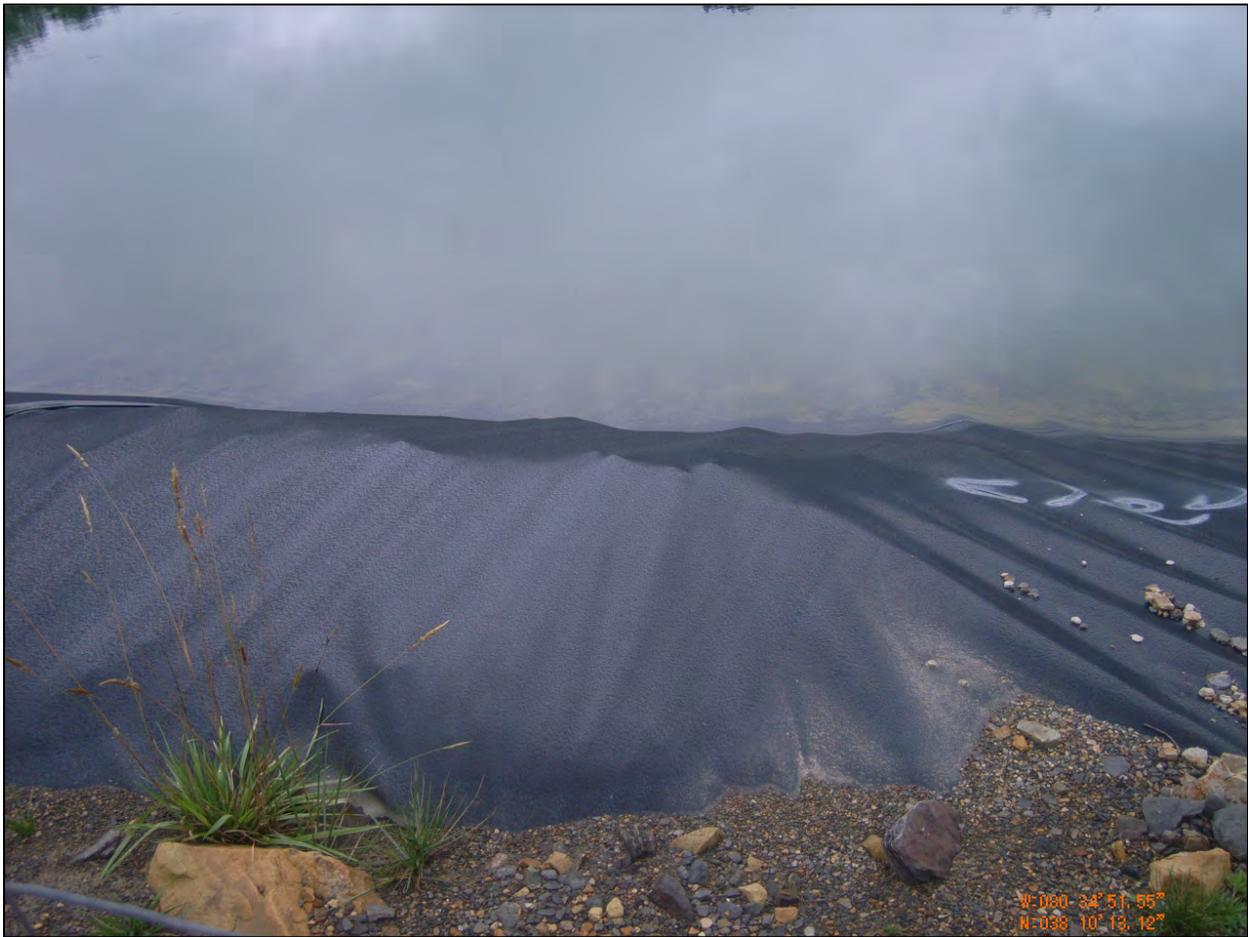
**Figure 16: Liner Bulges at MWV**

Another area of concern was bulges, tears, or holes in the liner, as indicated by Question 8. This problem was present at every site evaluated, with seven sites ranked as Low, four ranked as Moderate, and three ranked as High. Figure 16 depicts a liner stretched over an improperly prepared slope at the MWV Large Water Storage Pond 1. The underlying rock pressing on the liner and the strain caused by the bulges have a high likelihood to create tears or punctures in the liner and threaten the integrity of the containment system.

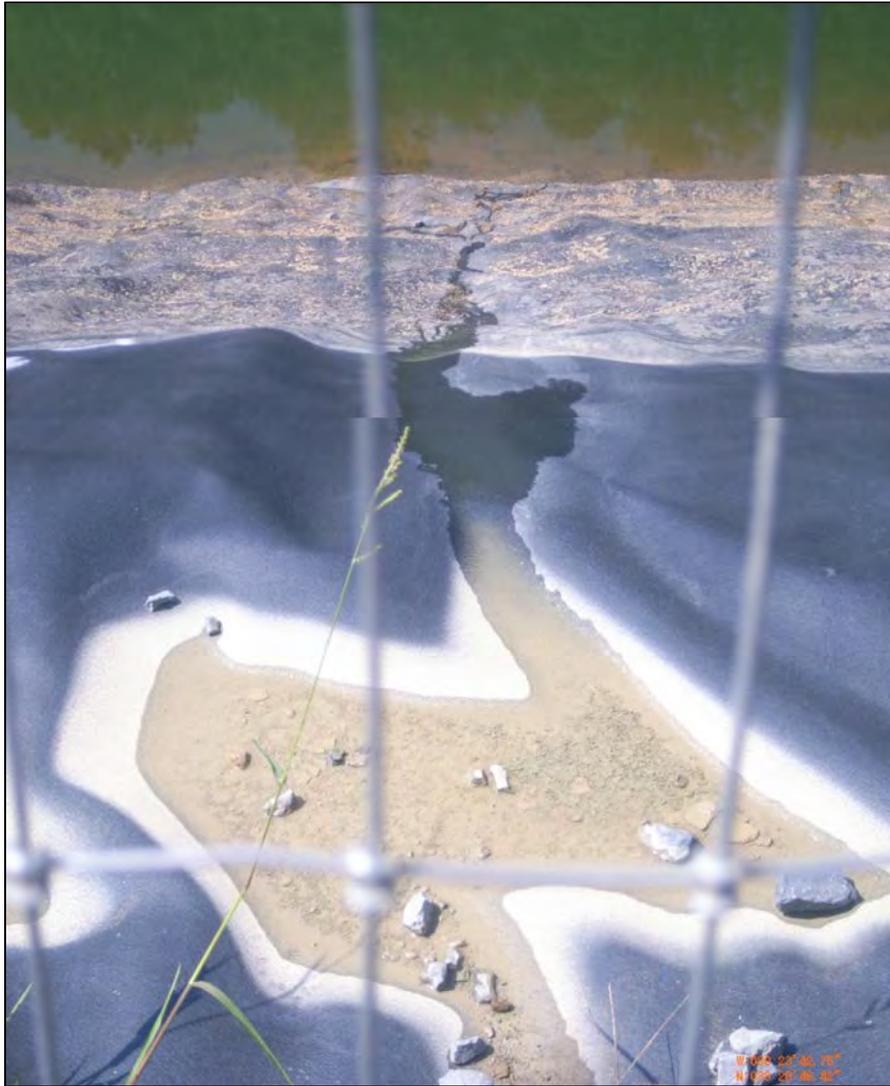
**Figure 17: Debris on Liner at Flanigan**

Question 10 involved the presence of rock or debris on top of the liner. This problem was observed at all sites except one. Figure 17 illustrates an example of a severe case of debris on the liner at the Flanigan Pit. At the Flanigan Pit as well as other sites visited, surface water was present on the berm and in the anchor trench. This practice is not in accordance with the West Virginia Erosion and Sediment Control Field Manual, which states that surface water must be diverted from the pit. The water washing the rock and debris into the pit adds weight to the containment system which can lead to strain and dislodgement of the anchor trench. Also, with the rock washing down over the liner, there is a higher potential for tears to form.

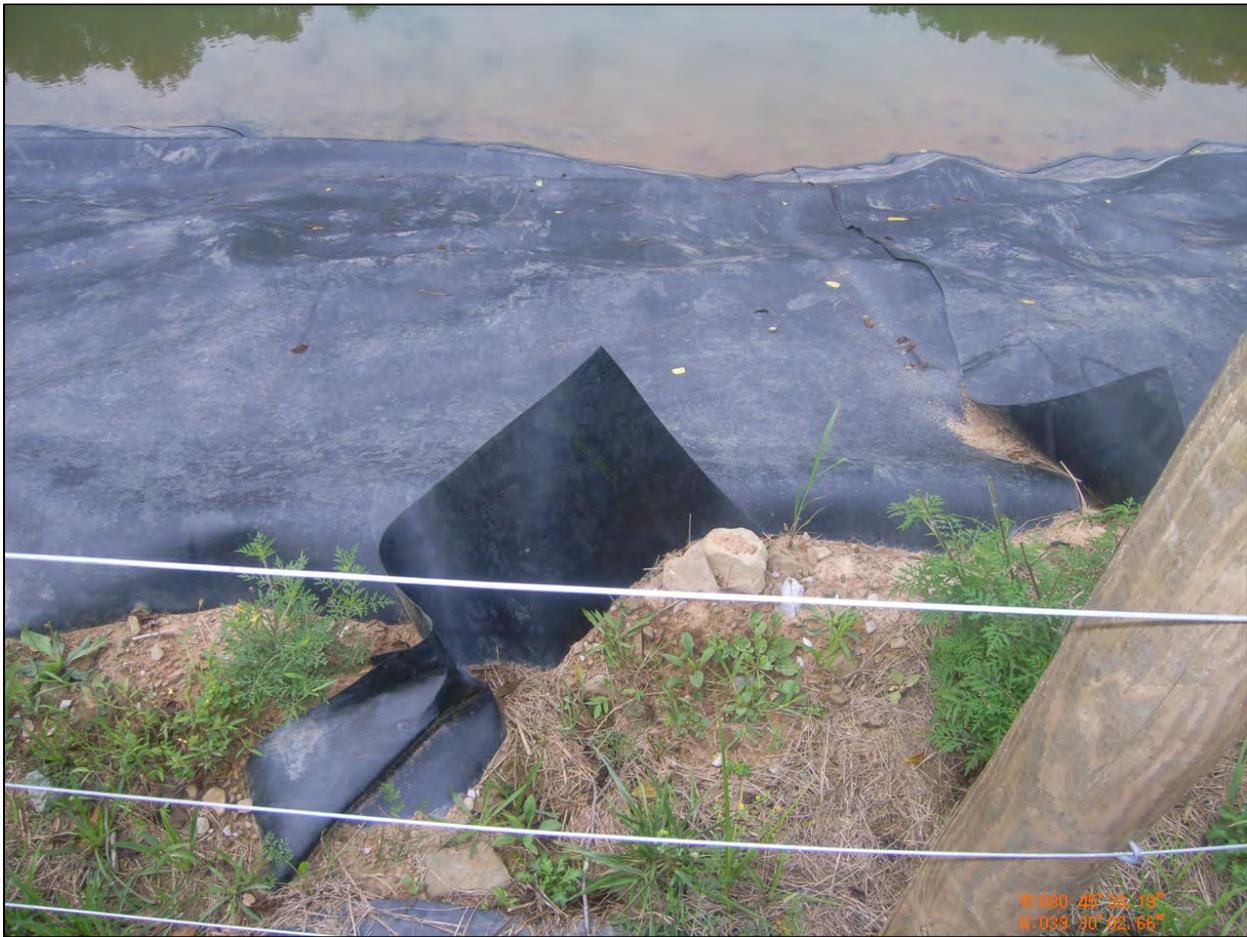
**Figure 18: Improper Anchor Trench Embedment at Ball 1H**

Deformations, cracks, and settlements around the anchor trench affect the integrity of the liner, and these concerns were addressed in Question 12 of the observation checklist. During field evaluations, this question was expanded to include the embedment of the anchor trench. All sites with the exception of one were found to have issues related to the anchor trench. Figure 18 illustrates improper anchor trench embedment at the Ball 1H Impoundment #2, as indicated by the liner protruding out of the ground. Improper embedment may result in an increased likelihood of the anchor trench pulling out of the soil, affecting the ability of the liner to retain fluids. Another potential issue is the possibility of wind lifting the liner and causing tears leading to a failure of the containment system.

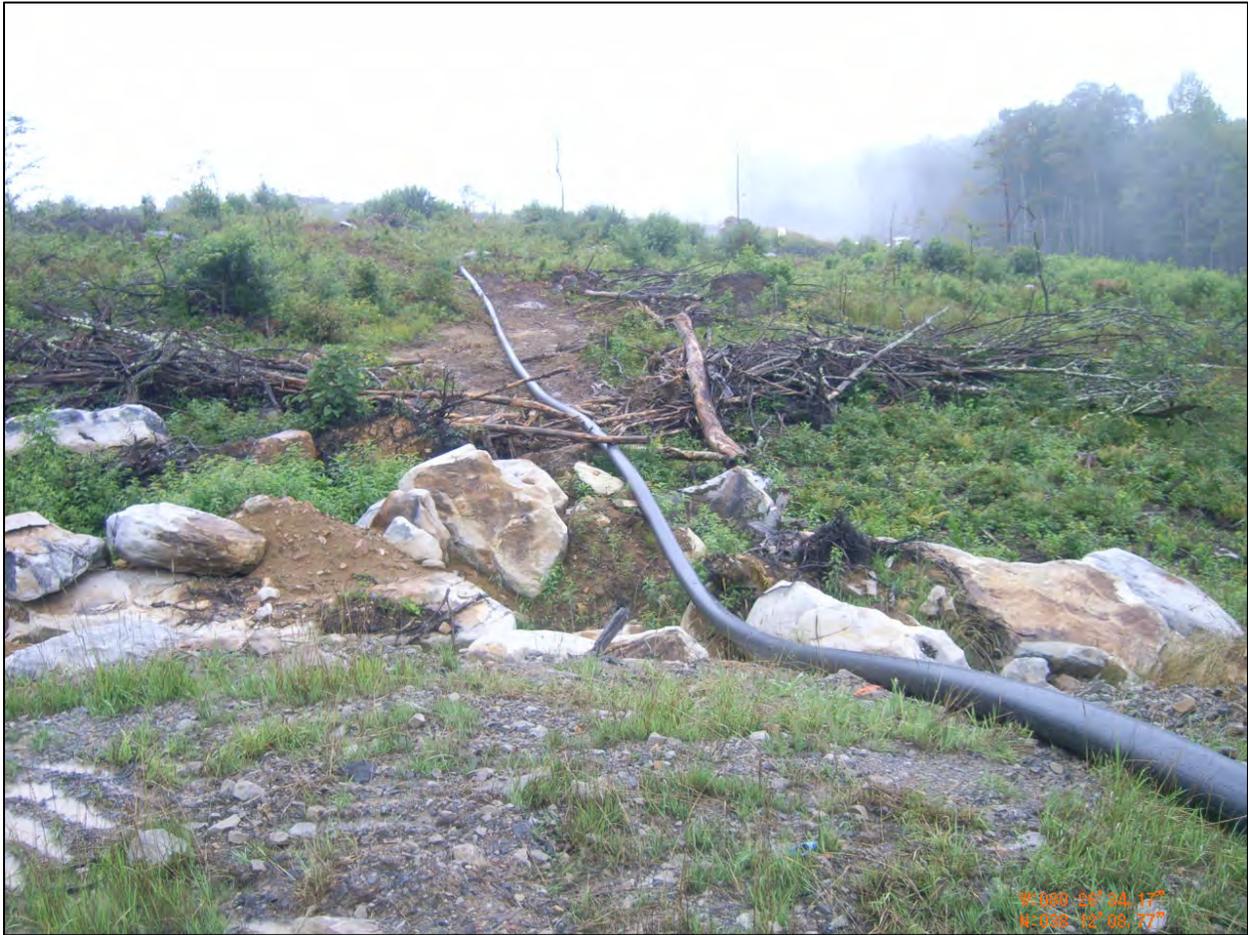
**Figure 19: Unsupported Pipe at Plum Creek**

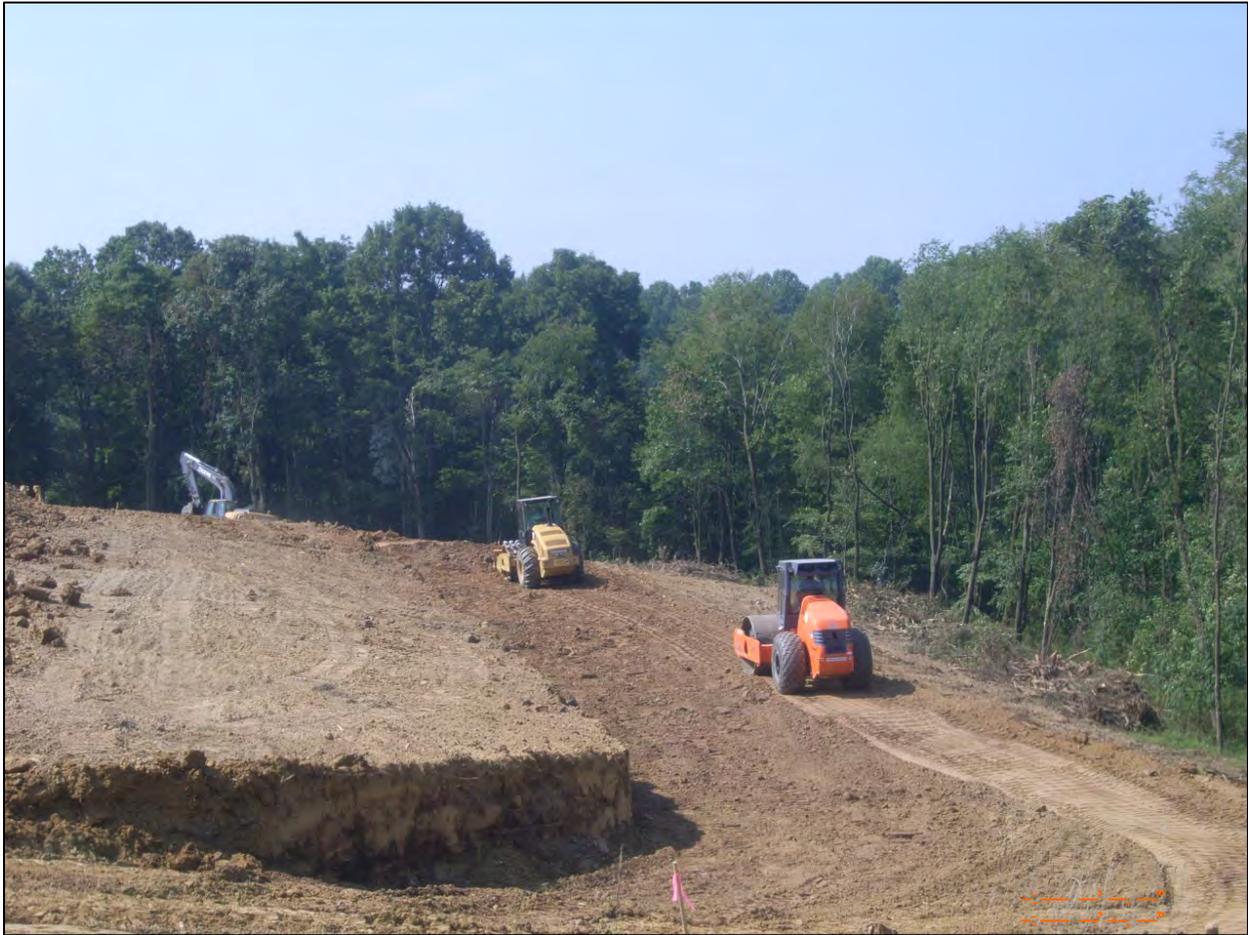
**Figure 20: Improper Compaction Practices**

In Figure 20, the excavator is placing the lift of soil, and the lift is being compacted by a sheep's foot roller, followed by a vibratory roller. According to the West Virginia Erosion and Sediment Control Field Manual, each lift shall be compacted by compaction equipment, sheep's foot or pad roller, with compaction to visible non-movement of the embankment material. Thus, the use of both a sheep's foot roller and a vibratory roller violates the best management practice in the manual. This construction practice is creating a shear plane on which water can move through the soil, possibly resulting in a slope failure. The sheep's foot roller kneads the soil, interlocking the soil lifts and benefiting compaction efforts, but the vibratory roller is negating this interlocking by smoothing the soil.
