**Re: *W. Va. Code §22-6A-23 Impoundment and Pit Safety Study***

### **INTRODUCTION**

### **ETD-10 Pits and Impoundments Evaluation Report Site Observations / Comments**

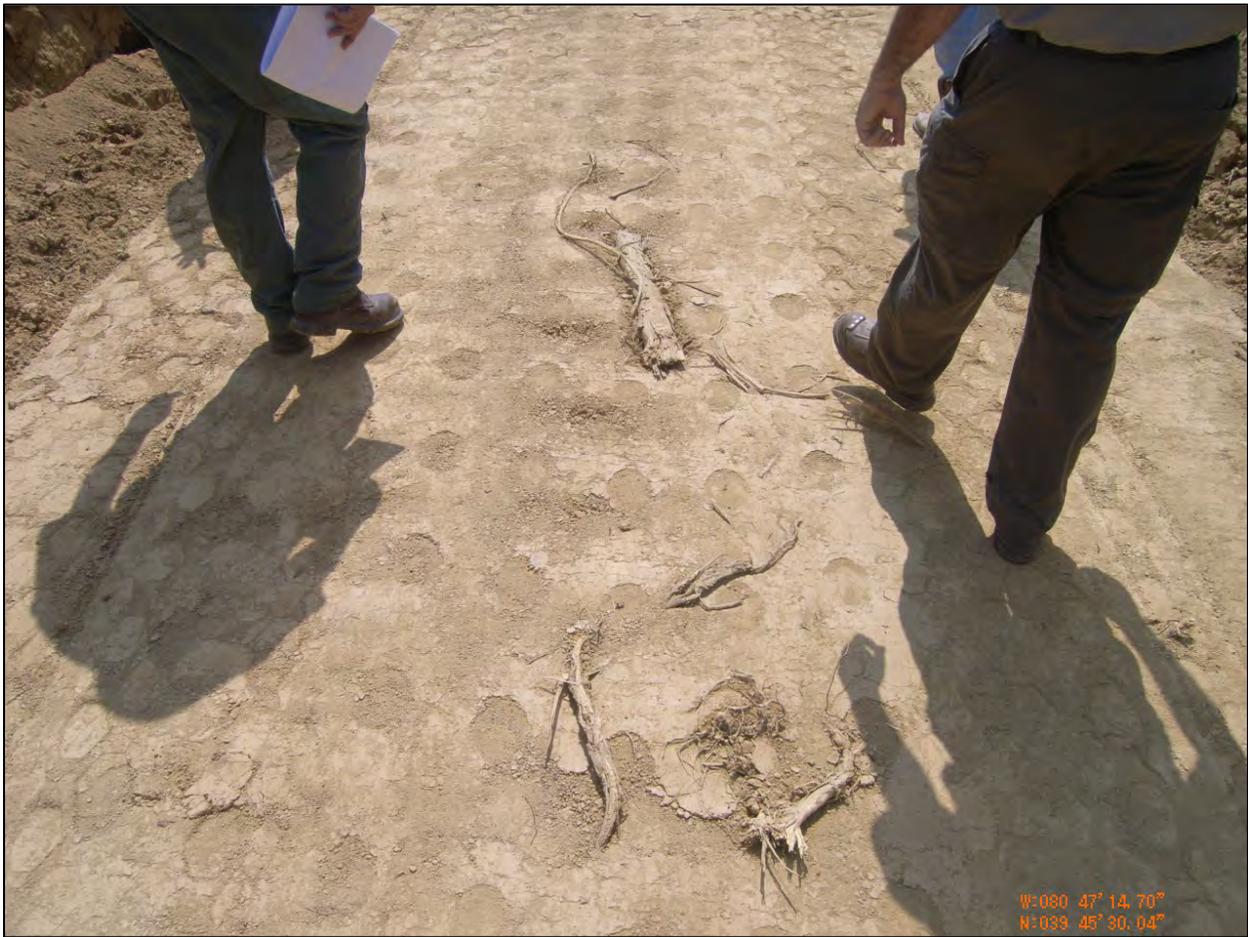
**Figure 21: Woody Debris in Soil Lift**

Figure 21 depicts woody debris that has been compacted into the fill, which was a recurring area of concern on a majority of the sites evaluated. The West Virginia Erosion and Sediment Control Field Manual states that the fill material shall be clean mineral soil, free of roots, woody vegetation, stumps, sod, large rocks, or other objectionable material. As Figure 21 shows, this best management practice is not being followed at the Shields FWI site. Organic material compacted into the fill may create pathways for water to infiltrate the soil and cause internal erosion, which is a possible failure mode for the structure.

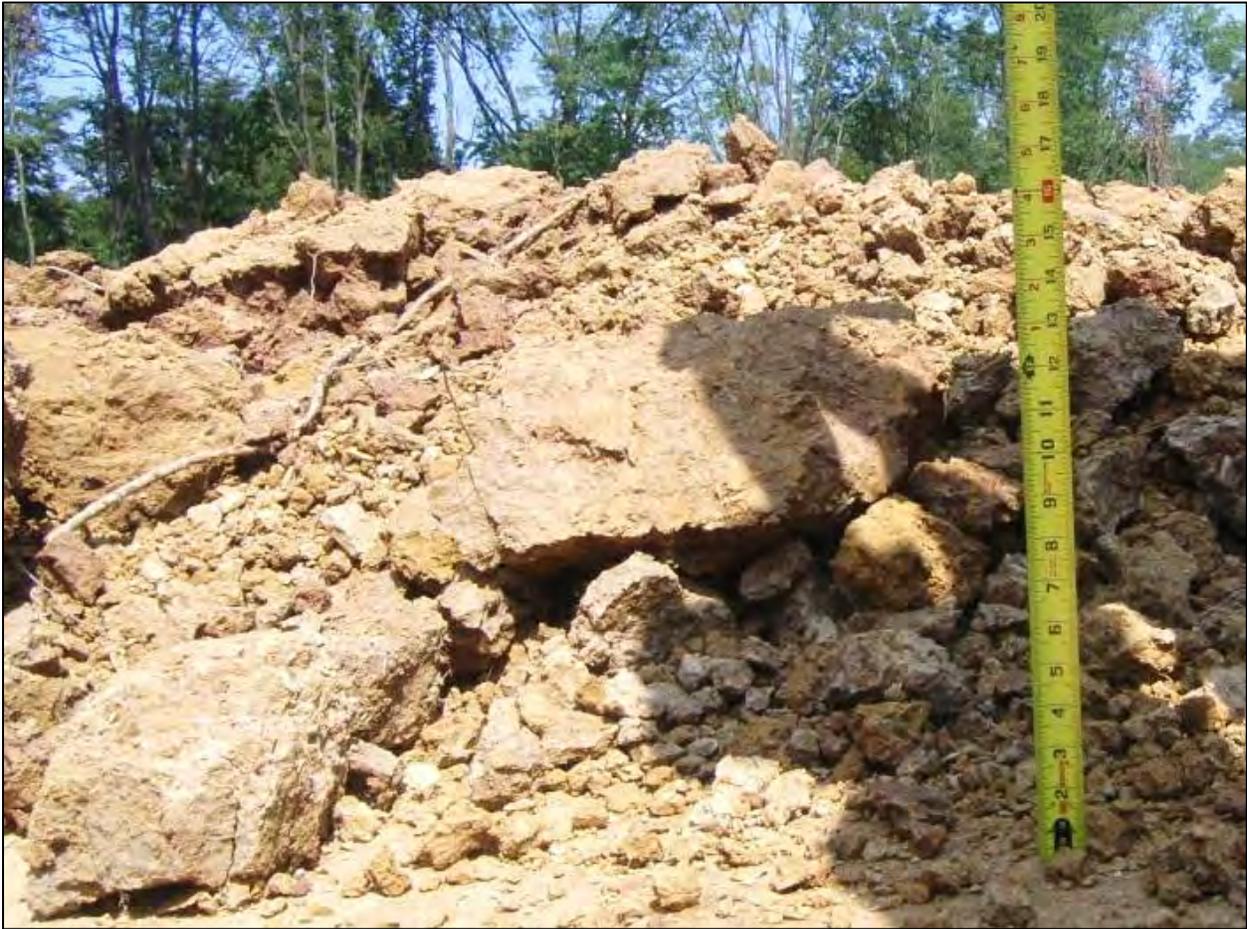
**Figure 22: Excessive Lift Thickness**

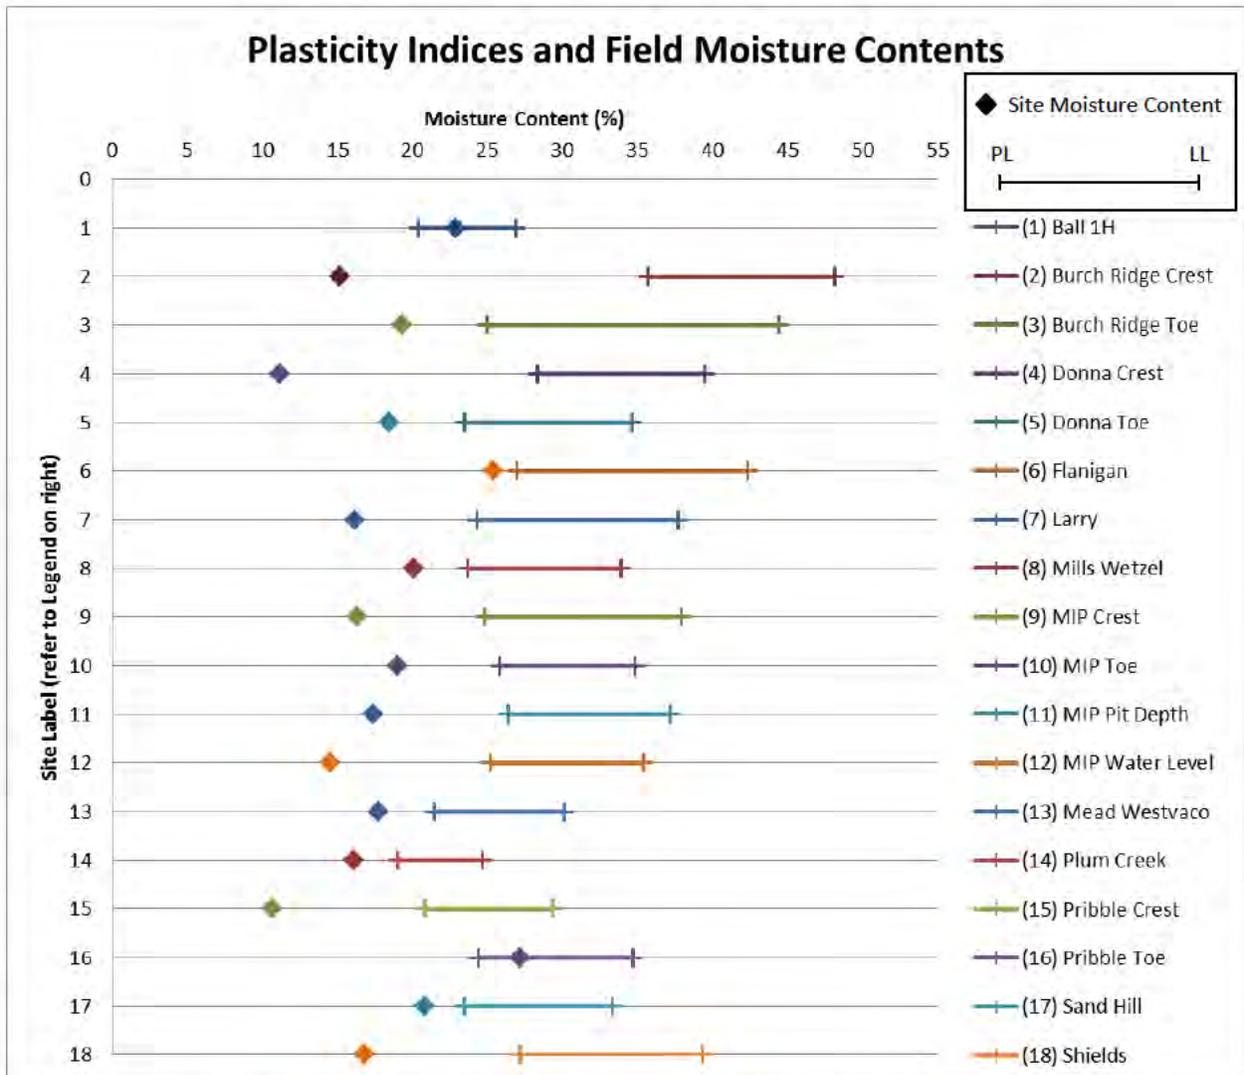
**Figure 23: Atterberg Limits and Field Moisture Content**

Once the laboratory testing was completed, the results from the various tests were compiled into tables and graphs in order to present the results in a convenient manner. Figure 23 illustrates the results of the Atterberg limits testing for each site. The range of moisture content values between the Plastic Limit (PL) and Liquid Limit (LL) is shown for each site, and the field moisture content is graphed as an illustration of the soil condition at the site. These values are displayed numerically in Table 7, where the results from the grain-size distribution and Atterberg limits tests for each site were used to classify the soil according to the ASTM D2487 Standard. According to the WVDEP Design and Construction Standards for Centralized Pits, the following soil classifications are acceptable for post §22-6A sites: Clayey Gravel (GC), Silty Gravel (GM), Clayey Sand (SC), Silty Sand (SM), Clay (CL), and Silt (ML). The laboratory testing results indicated that none of the post §22-6A sites met this requirement, and of the remaining 12 pre §22-6A sites, only one site met the soil standards.

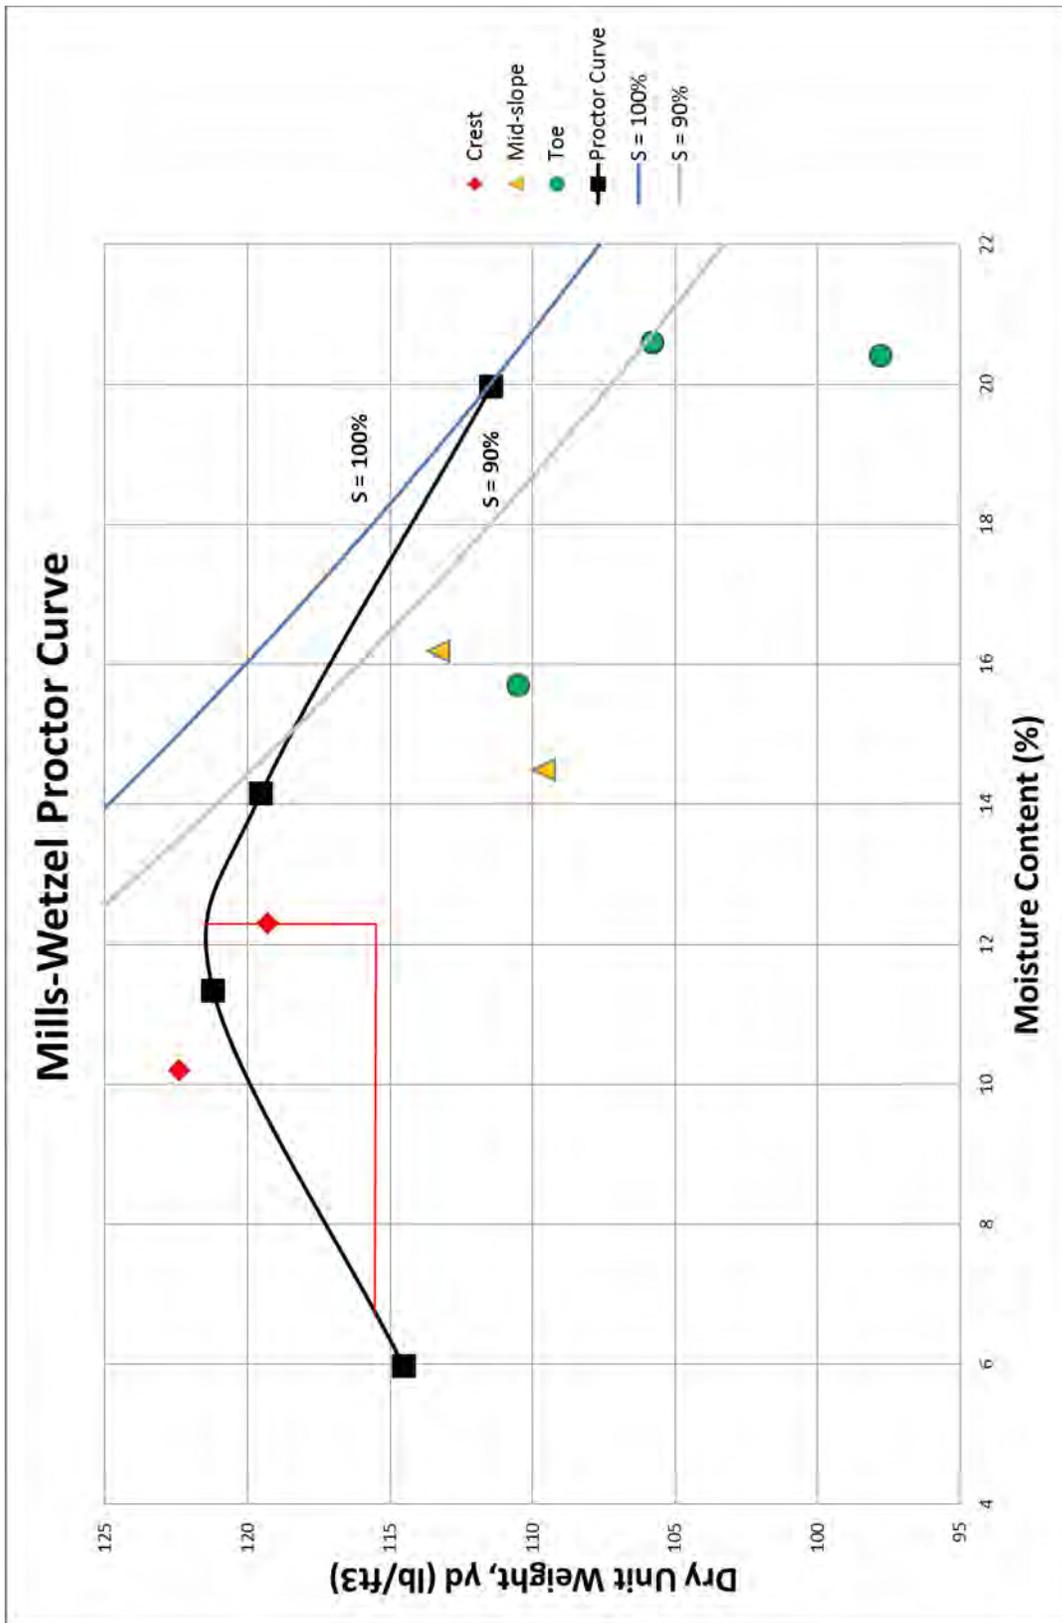
Figure 24: Mills-Wetzel Compaction

The West Virginia Erosion and Sediment Control Field Manual requires that soil lifts shall be compacted to a standard Proctor density of at least 95% and that compaction effort shall not exceed optimum moisture contents. In order to compare the adherence of site construction practices to this standard, a standard Proctor density of 95% of the optimum dry density was computed for each site. To achieve proper compaction on-site, the moisture content should be on the dry side of the optimum moisture content. Therefore, the appropriate compaction density and moisture content range was plotted on the graphs, signified by red lines. Lastly, the field data obtained by the nuclear density gauge readings was organized by the location of the reading (crest, mid-slope, toe) and graphed to determine how the field compaction compared with the laboratory results. The graphs for the Mills-Wetzel Freshwater Impoundment and the Larry Pad are presented in Figures 24 and 25, respectively, while the graphs for the remaining sites are contained in the corresponding Appendices.

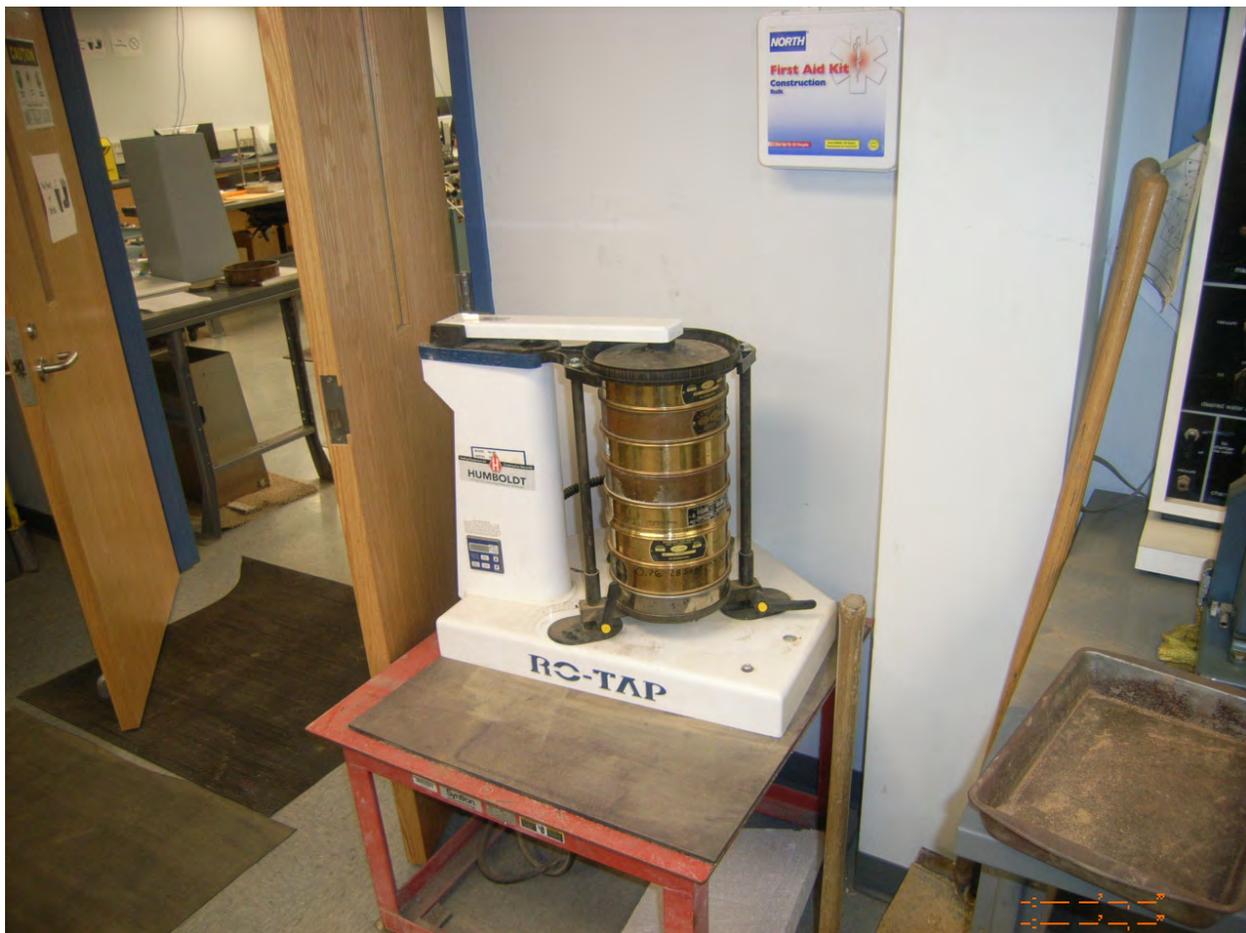
**Figure 26: Sieve Shaker**

Grain-size distribution is useful in estimating hydraulic conductivity and also in finding the engineering properties of soil. The ASTM method used for the grain-size distribution testing was ASTM D422. The grain-size distribution testing was performed by placing soil samples in the sieve shaker for five minutes. Table 13 gives the list of sieves used for the grain-size distribution throughout this study. The sieves were cleaned after each use. The sieve shaker used for performing the grain-size distribution testing is shown in Figure 26.

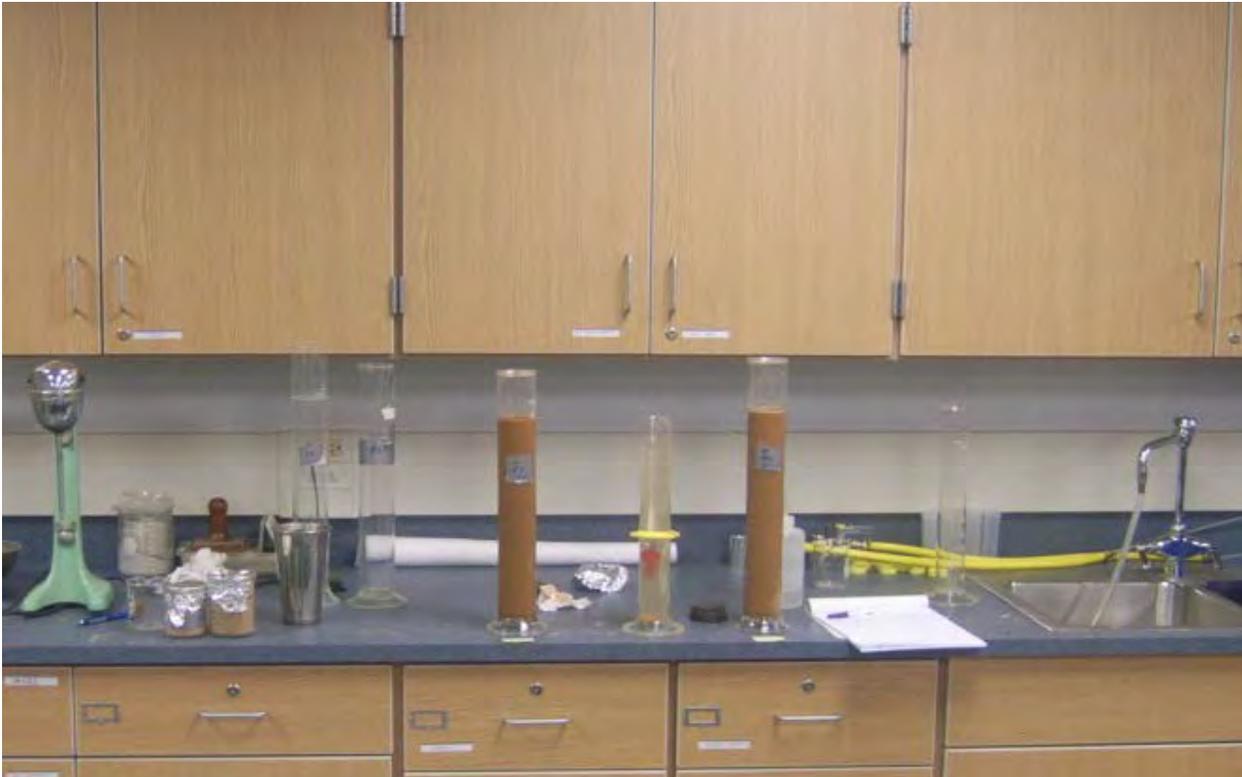
**Figure 27: Hydrometer Analysis**

The sieve analysis and particle diameters were used to classify the soil using the USCS classification methodology. Soil particles that passed the No. 200 sieve were used to perform the hydrometer testing as per the ASTM method. The hydrometer tests were conducted by making a blend of water, soil particles passing the No. 200 sieve, and the dispersing agent sodium hexametaphosphate. A calibrated hydrometer was used to measure the suspension of the soil particles in the blend at total elapsed times of 2, 5, 15, 30, 60, 250, and 1440 minutes. Two 1000 milliliter graduated cylinders were used for the test. After each reading, the hydrometer was kept in another 1000 milliliter graduated cylinder filled with water to clean the hydrometer between readings. The hydrometer testing apparatus is shown in Figure 27. Figure 28 shows hydrometer readings being careful observed and recorded.

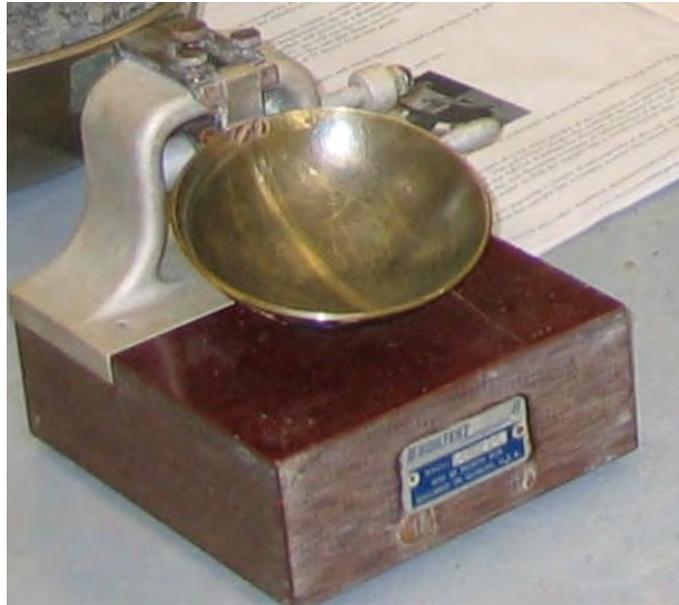
**Figure 29: Liquid Limit Device (Casagrande Cup)**

The ASTM D4318 method was used to determine the Atterberg Limits for this study. Specific water contents were taken to blend with the soil. The blend was placed in a liquid limit apparatus, shown in Figure 29, and a groove was made using a standard-width grooving tool. The cup was dropped until the groove closed, and the number of blows was counted. The water content at which the groove closes at 25 blows is defined as the liquid limit. The plastic limit was determined by rolling the soil into 1/8 inch diameter threads and measuring the water

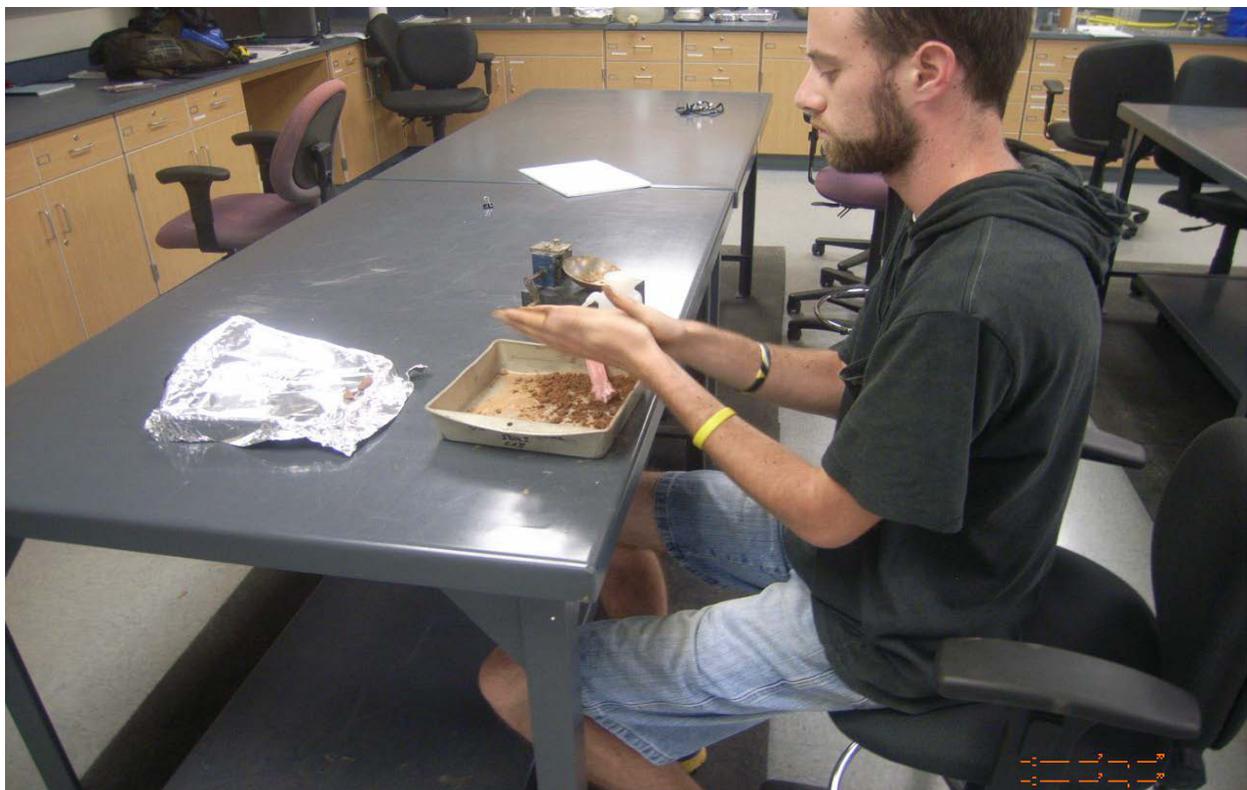
**Figure 30: Atterberg Limits Testing**

content at which the threads crumbled. The Plasticity Index was then calculated using the liquid limit and plastic limit values. This testing procedure is illustrated in Figure 30.

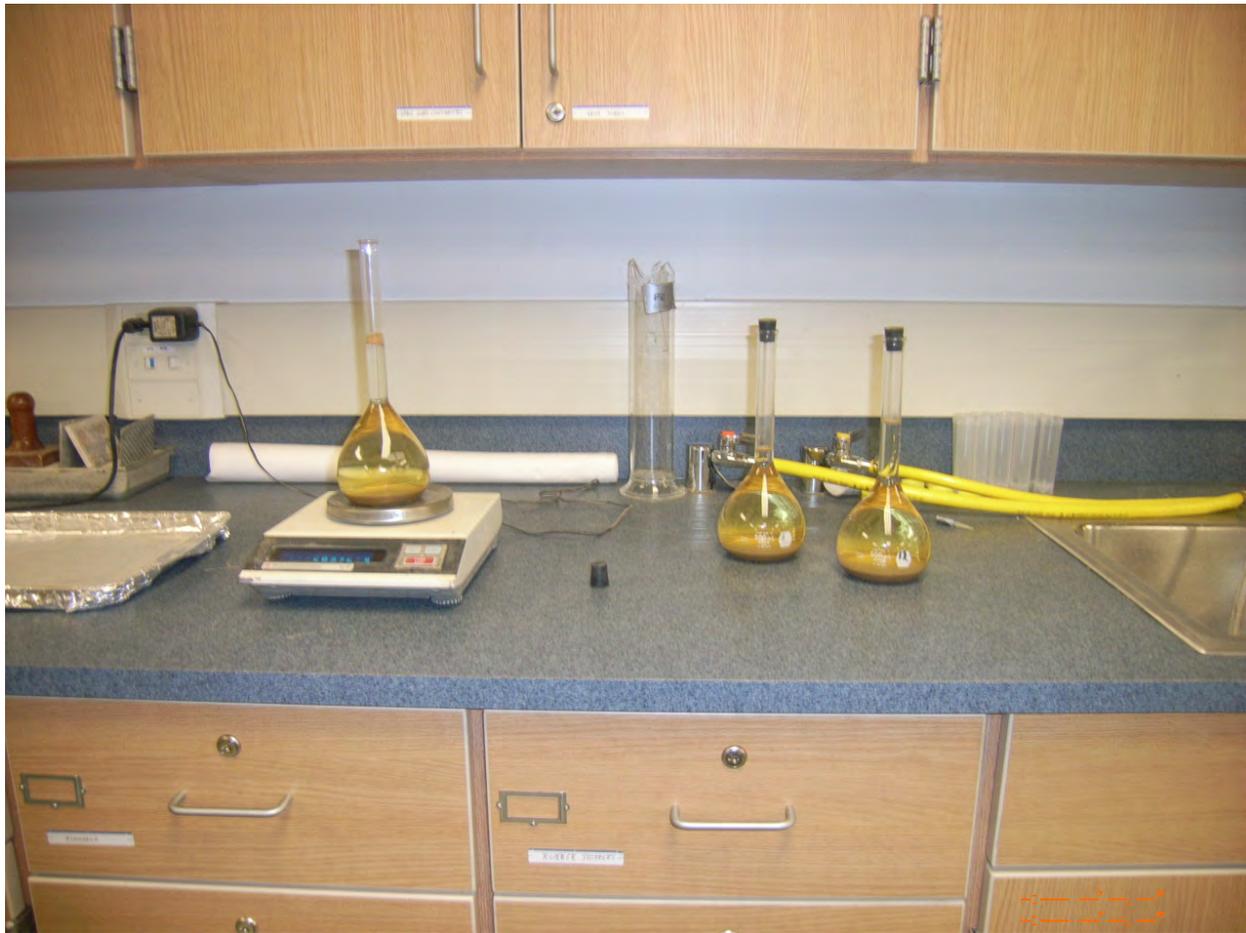
**Figure 31: Specific Gravity**

Specific gravity is defined as the ratio of the unit weight of a given material to the unit weight of distilled water at 4°C. Specific gravity testing is performed to find the dry density, void ratio, and degree of saturation, and the results are also used in the hydrometer analysis calculations. The method used for the determination of specific gravity was ASTM D854 - Method A, in which a water pycnometer was used. The test was performed by weighing the pycnometer containing soil particles suspended in distilled water and taking the weight of equal volume of water in the same pycnometer. An air vacuum was applied for 2 hours during the test. The apparatus used for the specific gravity test is shown in Figure 31.

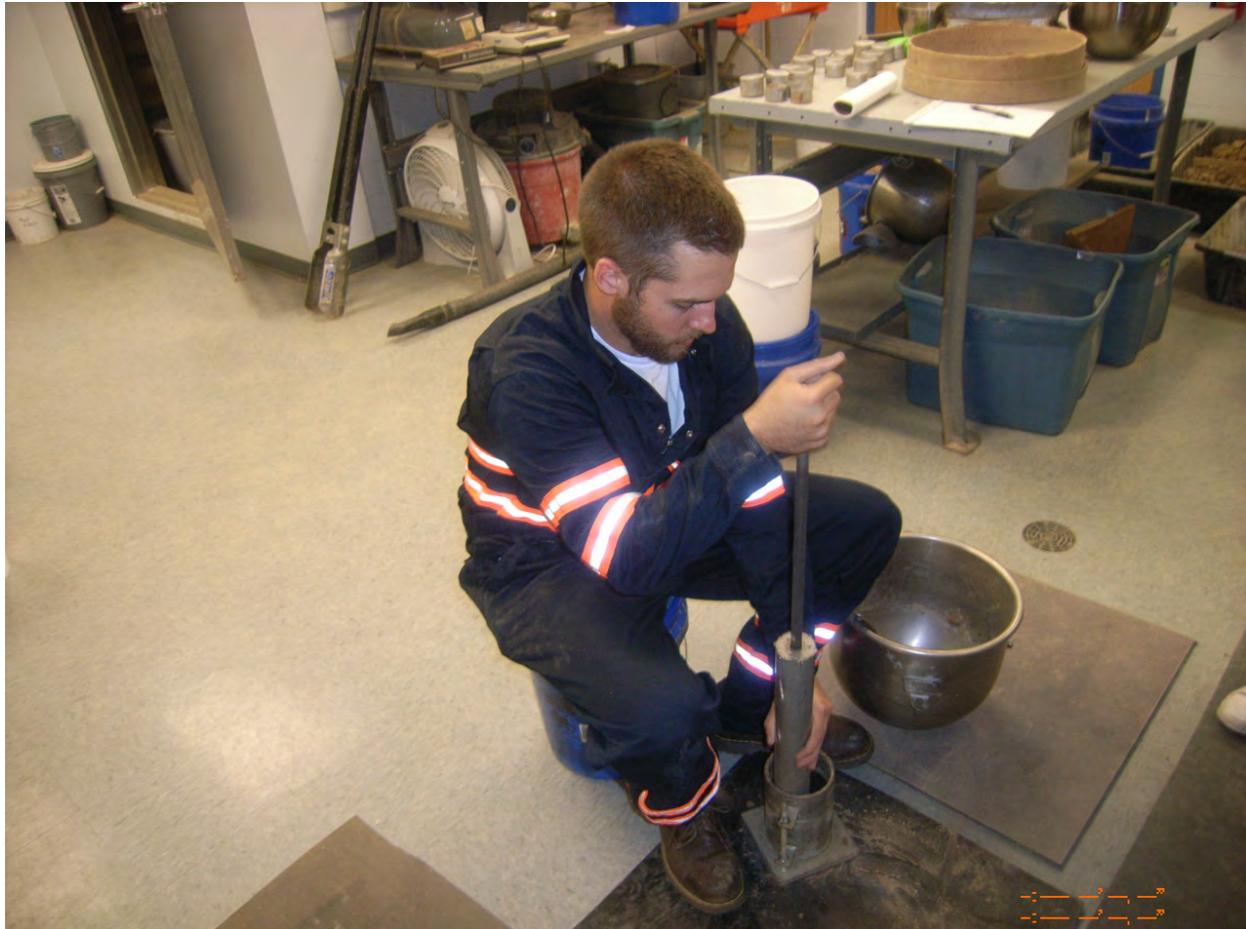
**Figure 32: Compaction Mold and Hammer**

remove the compacted sample from the mold. The compaction mold and hammer are shown in Figure 32.

Four samples from each site were prepared using different water contents. The soil samples were mixed with water and compacted in three layers with 25 blows per layer, in accordance with the ASTM method. After the compaction, the collar was removed, and the excess soil was trimmed to the surface of the mold. Figure 33 depicts the removal of the sample from the mold using a jack, leaving the compacted sample shown in Figure 34. After weighing each sample, discrete moisture contents were taken by cutting the sample into three equal layers and collecting a small amount of soil from the top, middle, and bottom layers. Using the results of the compaction testing, graphs of water content versus respective dry densities were developed, presenting the optimum moisture content and the maximum dry density of the sample.

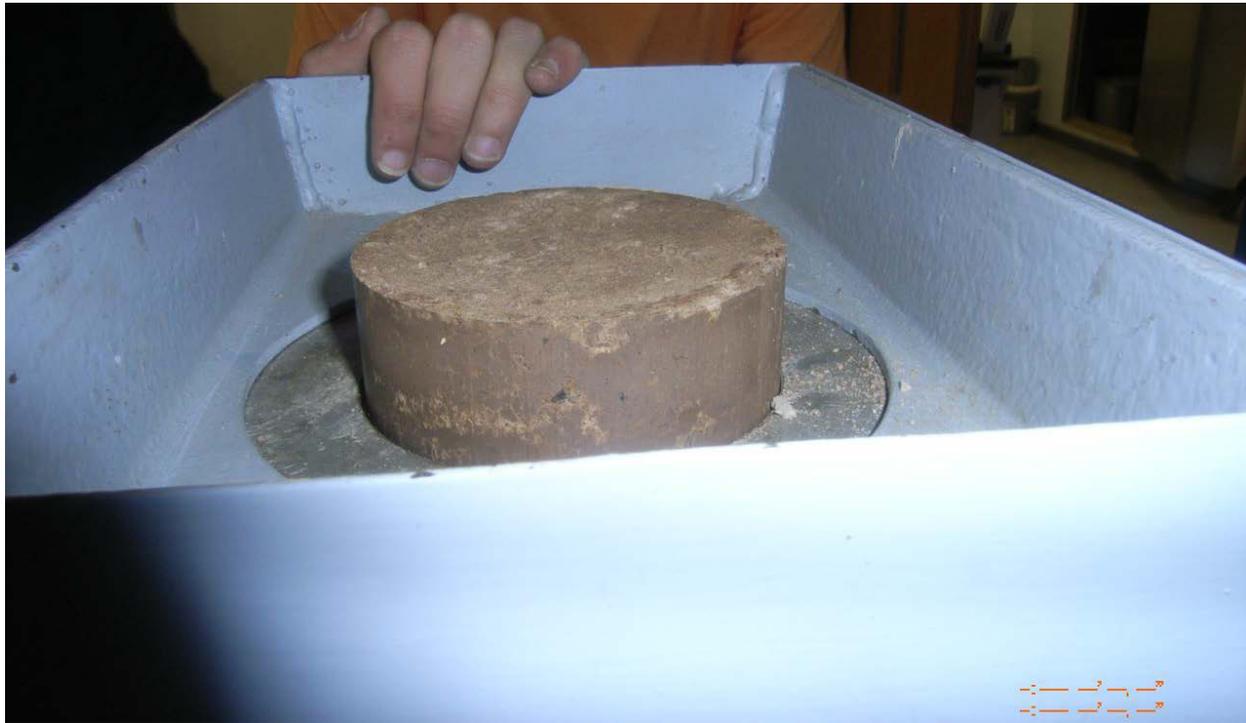
**Figure 33: Removal of Compacted Specimen from Mold Using Jack**

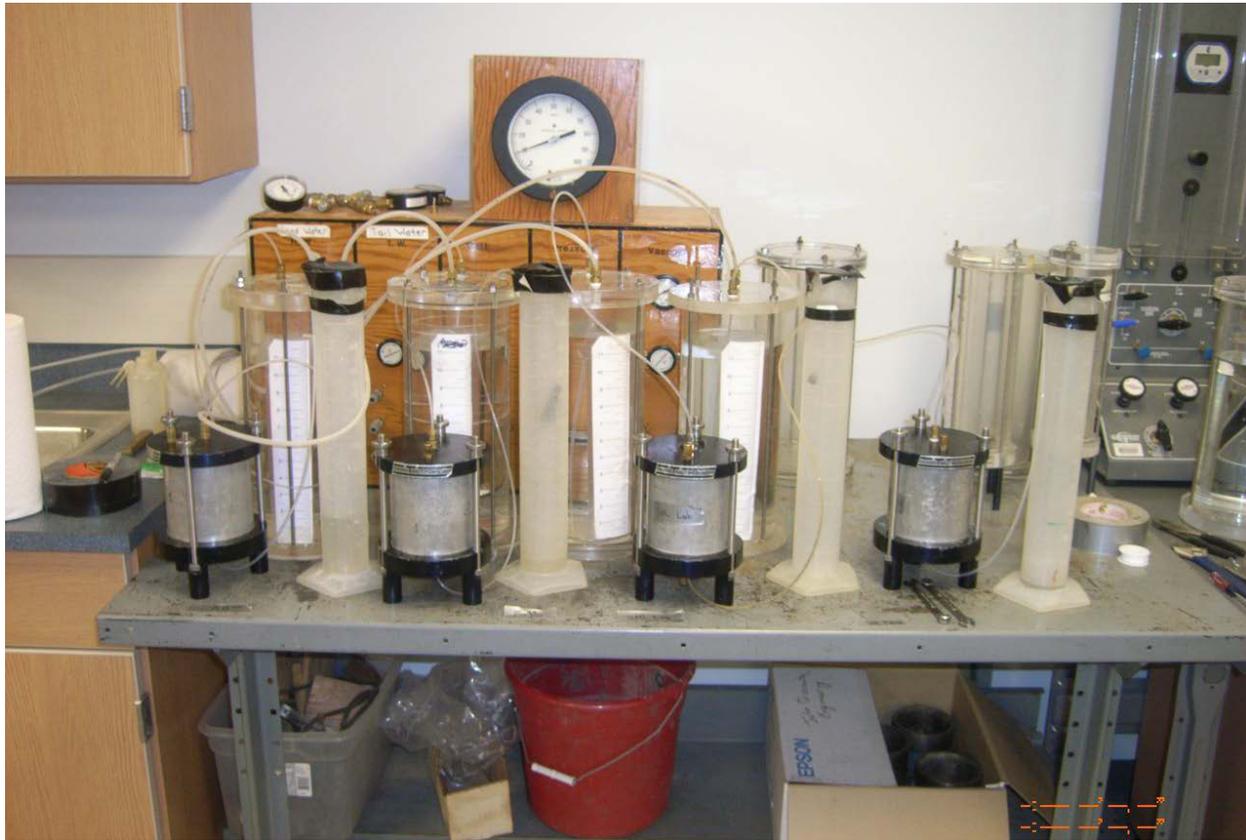
Hydraulic conductivity testing was performed using the ASTM D5856 method. The objective of the hydraulic conductivity testing was to determine the permeability of water through a test specimen at the optimum and field moisture contents of the material at each site. Two samples were compacted to optimum and field moisture contents using the Standard Proctor procedure outlined above. Once compacted, the samples were connected to a head-water reservoir and a pressure board to push water through the samples at a hydraulic gradient of 100 pounds per square inch. Readings were taken at varying intervals depending on the sample, or until the readings stabilized. After the hydraulic conductivity readings reached equilibrium, the hydraulic conductivity was determined. Figure 35 depicts four samples undergoing hydraulic conductivity testing.

**Figure 35: Hydraulic Conductivity Testing**

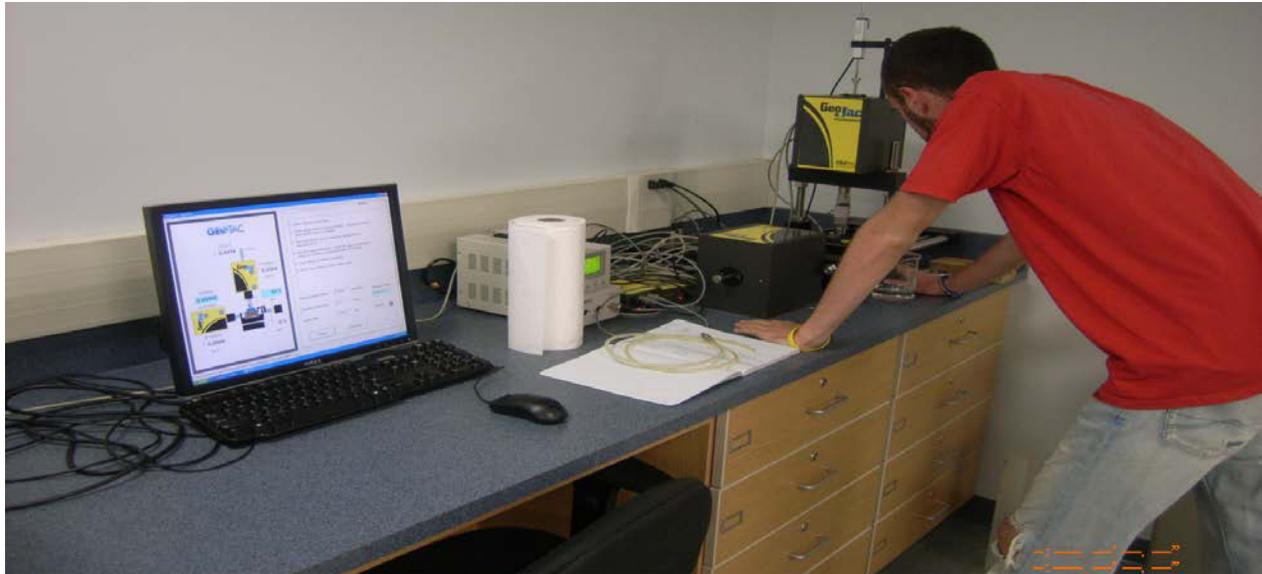
performed on a GeoJac direct shear testing device. The testing followed the procedures outlined in ASTM D3080/D3080M. Once the hydraulic conductivity testing for a site was completed, three cylinders measuring 2.5 inches in diameter and 1 inch in height were cut from the top, middle, and bottom of each sample. Each test was performed at an optimum and field condition. The internal angle of friction ( $\phi$ ) was calculated using Mohr-Coulomb failure criterion concepts. The testing setup and equipment are shown in Figure 36.

**Figure 36: Direct Shear Testing**

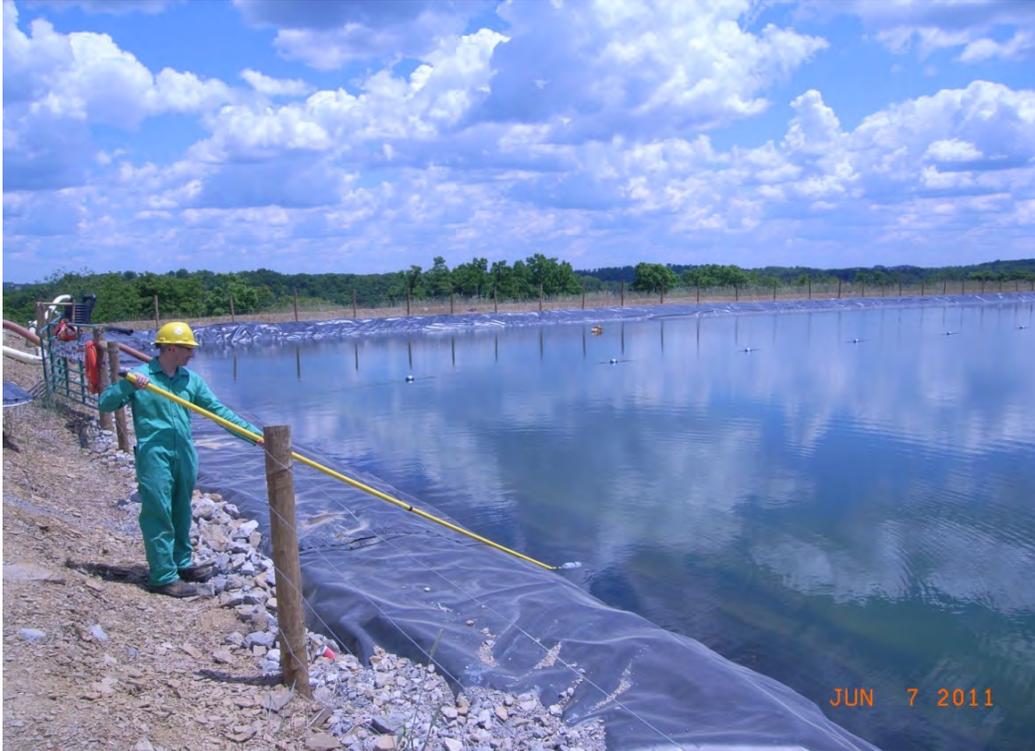
**Figure 2: SHL-1 Impoundment Sampling**

**Figure 1** is a map of the three Consol/Noble centralized impoundments-to-pits with incorporated coordinates. **Figures 2 and 3** illustrate initial sampling activities of the impoundments.

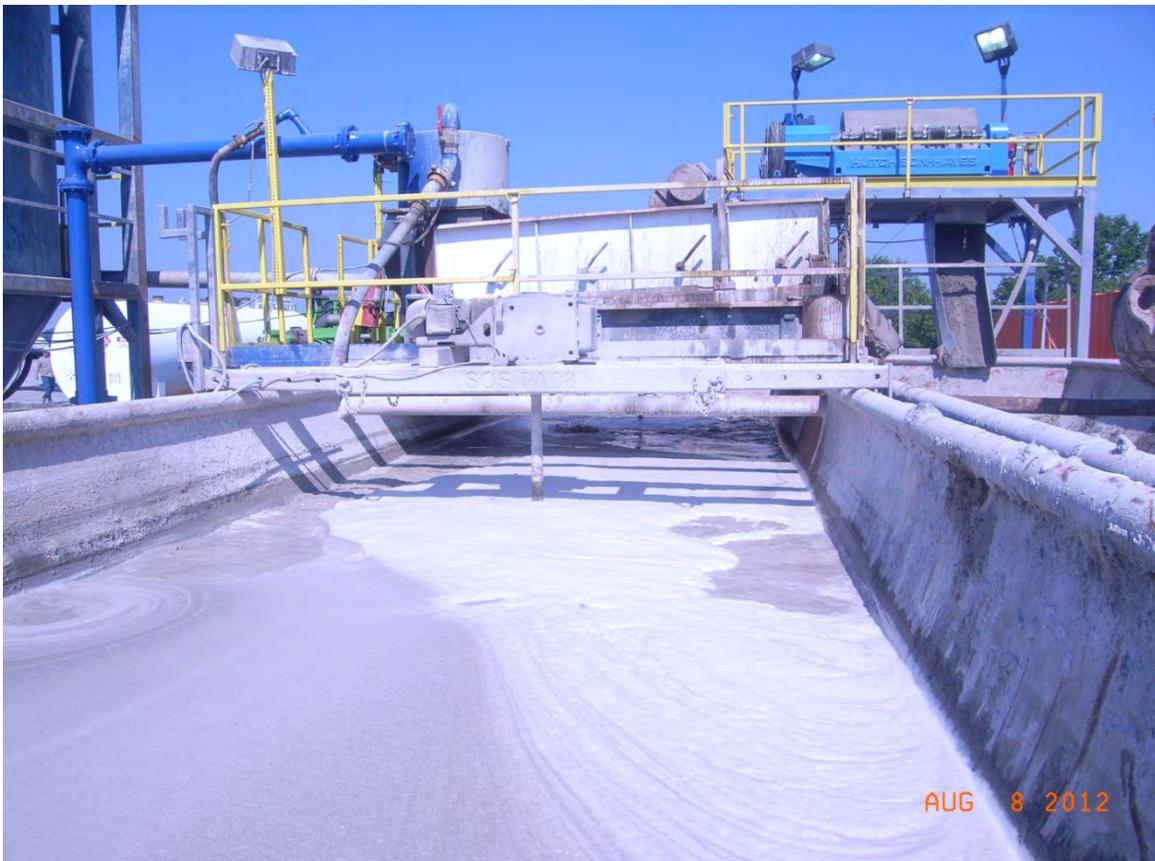
**Figure 4: Lemons Pad – Shaker Table Liquids**

Four samples of liquids and solids (muds and cuttings) generated during the vertical drilling phase of a horizontal well were collected from the Lemons Pad – Stone Energy site. The last of these samples was taken while air monitoring equipment was in use on the site. The point of collection for both the liquid and solid samples at the Lemons Pad is illustrated in **Figures 4 and 5** and **Figure 6** shows a sample of the drilling fluids. For the WVDNR A site, one sample of the produced drilling solids and liquids was collected. Sample collection at both sites was coordinated with the air monitoring team.

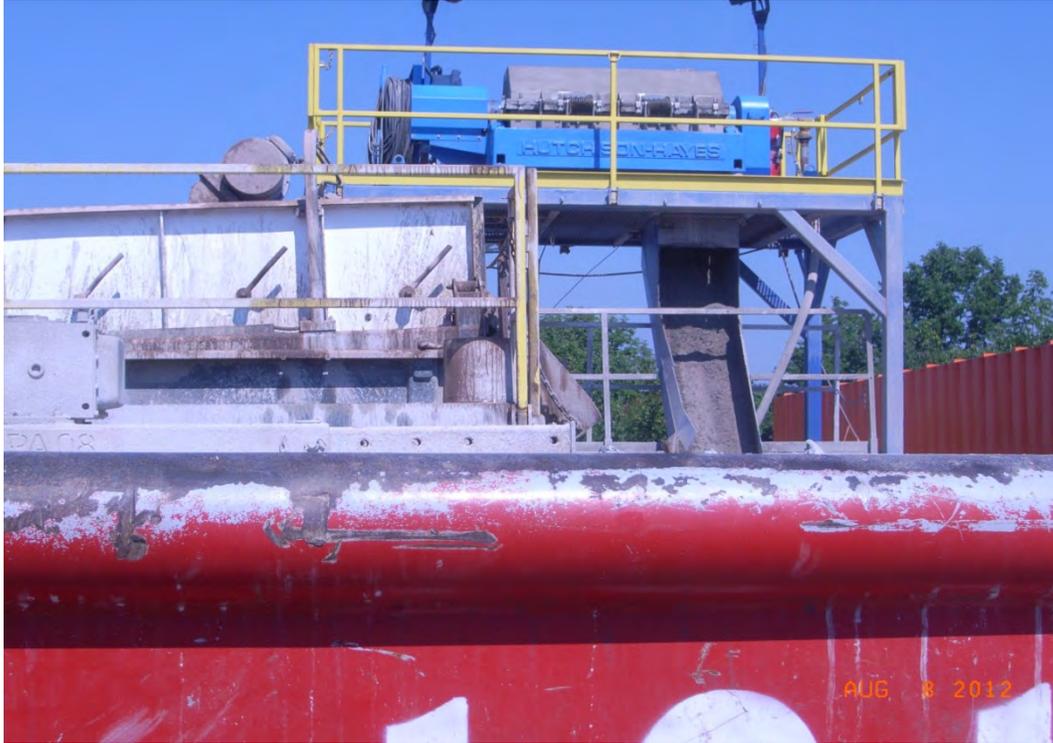
**Figure 7: Mills Wetzel Pad #2 Shaker Table (where samples were pulled)**

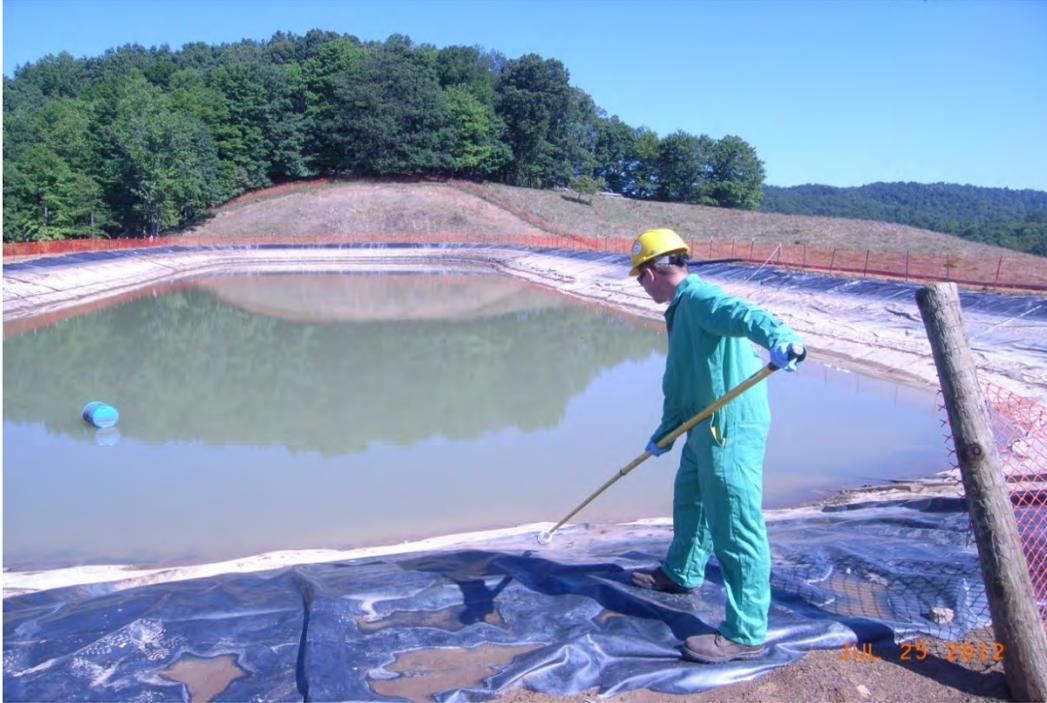
Samples of the water used to mix with the hydraulic fracturing fluids (makeup water) were taken from the Donna Pad storage pit by using a swing sampler as shown in **Figure 8**. Samples of the hydraulic fracturing fluids and water mixture were taken from the blender prior to entering the Donna Pad well. Hydraulic fracturing sampling activities of well pad staff and the location of the sampling point are illustrated in **Figures 9 and 10**. Sample collection was coordinated with the air monitoring team at each of the sites. Hydraulic fracturing samples were taken on 9/11/12 at the Maury Pad. The makeup water sample was retrieved from an on-site holding tank and the hydraulic fracturing fluid sample was taken after the blender, prior to entering the Maury Pad well. Sampling at the Maury pad was coordinated with the air monitoring team.

**Figure 8: Donna Pad Pit Sampling of Hydraulic Fracturing (Makeup) Water**

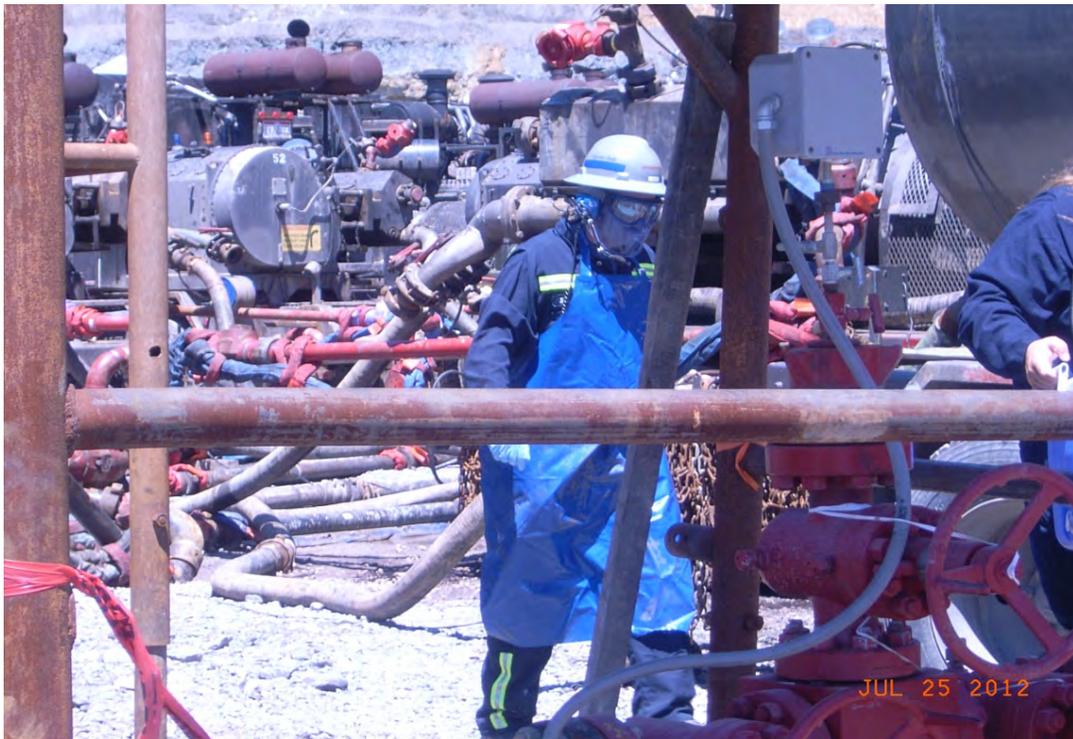
**Figure 9: Sampling Hydraulic Fracturing Fluids and Water Mixture before Entering Well**

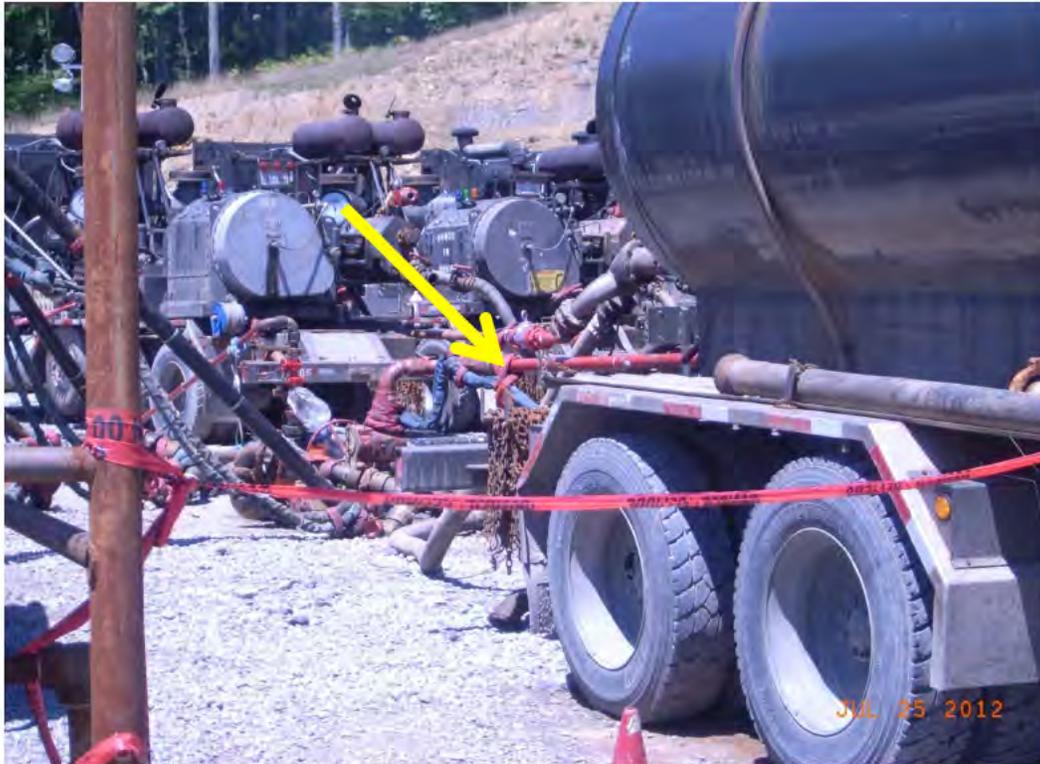
**Figure 10: Sampling Location of Hydraulic Fracturing Fluids**

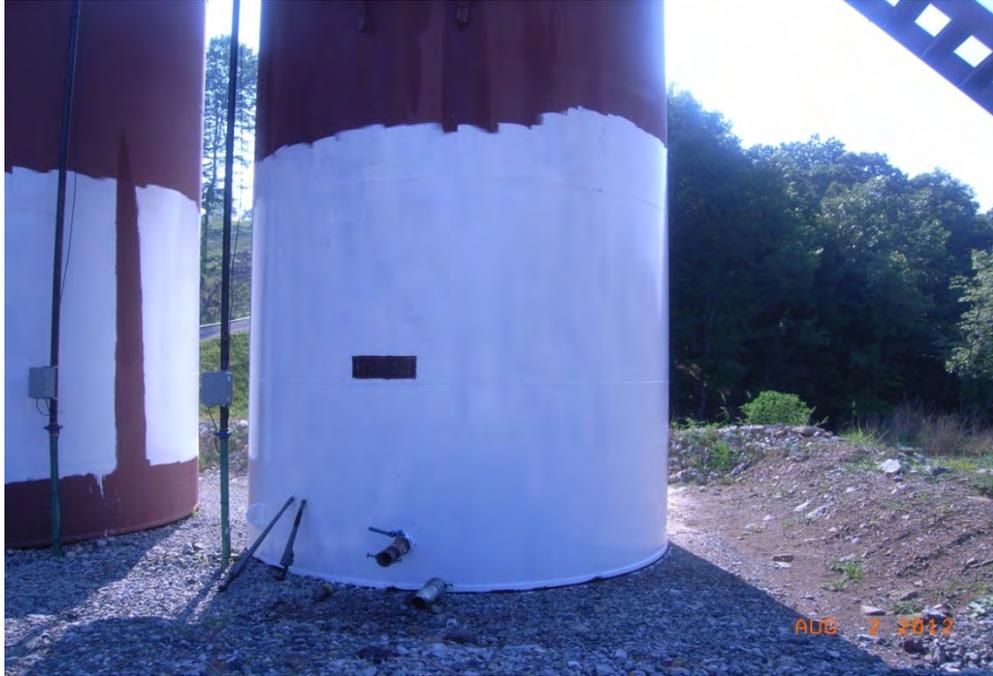
**Figure 11: Flowback Sampling Point at Condensate Tanks, Donna Pad**

Flowback samples were collected at a condensate tank on the Donna Pad – WACO/ECA as shown in **Figure 11**. **Figure 12** shows the point-of-collection for the composite liquid and solids sample of flowback/produced water on the Donna Pad. This type of pit structure is typical among the sites visited. **Figure 13** is the sample area at the Weekley pad. The sample was taken from a separator. **Figure 14** is the Sand Hill #3 and #4 pits. A composite sample was taken from six different points (each corner and the middle of the long sides) in the pit from the Sand Hill #4 Pit (SHL-4). The six samples were combined into a composite sample, which was used to fill all sampling bottleware.
