**Re: *W. Va. Code §22-6A-23 Impoundment and Pit Safety Study***

### **INTRODUCTION**

### **ETD-10 Pits and Impoundments Evaluation Report Site Observations / Comments**

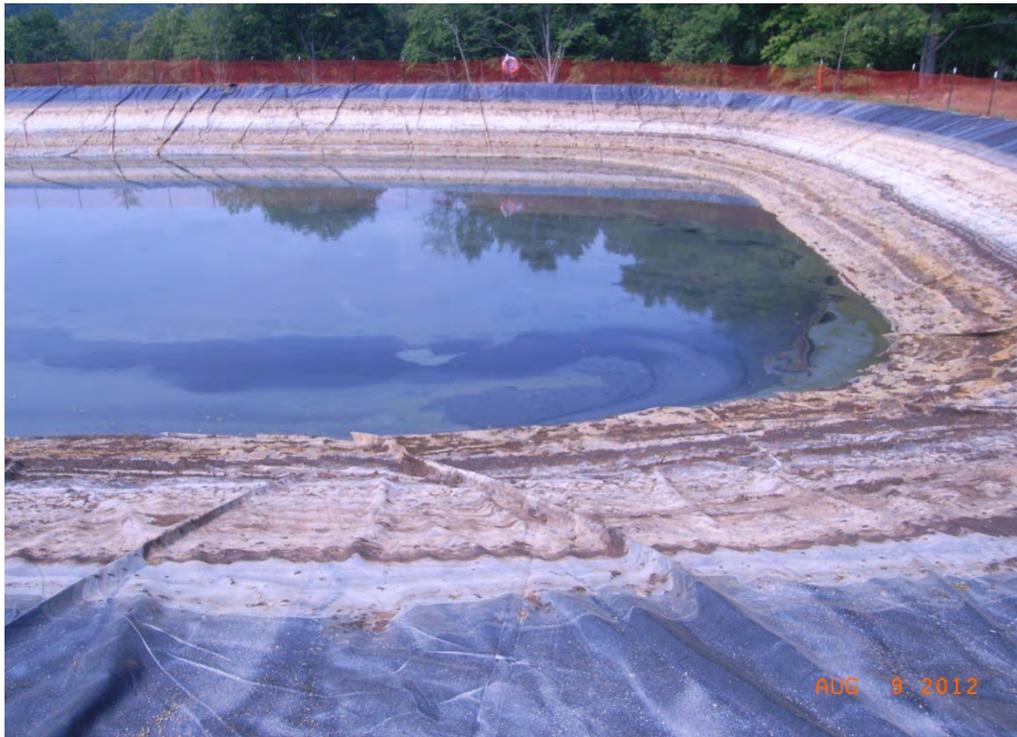
**Figure 12: Composite Flowback Stream Sample at Donna Pad Single-Lined Pit**

Flowback samples were collected at a condensate tank on the Donna Pad – WACO/ECA as shown in **Figure 11**. **Figure 12** shows the point-of-collection for the composite liquid and solids sample of flowback/produced water on the Donna Pad. This type of pit structure is typical among the sites visited. **Figure 13** is the sample area at the Weekley pad. The sample was taken from a separator. **Figure 14** is the Sand Hill #3 and #4 pits. A composite sample was taken from six different points (each corner and the middle of the long sides) in the pit from the Sand Hill #4 Pit (SHL-4). The six samples were combined into a composite sample, which was used to fill all sampling bottleware.

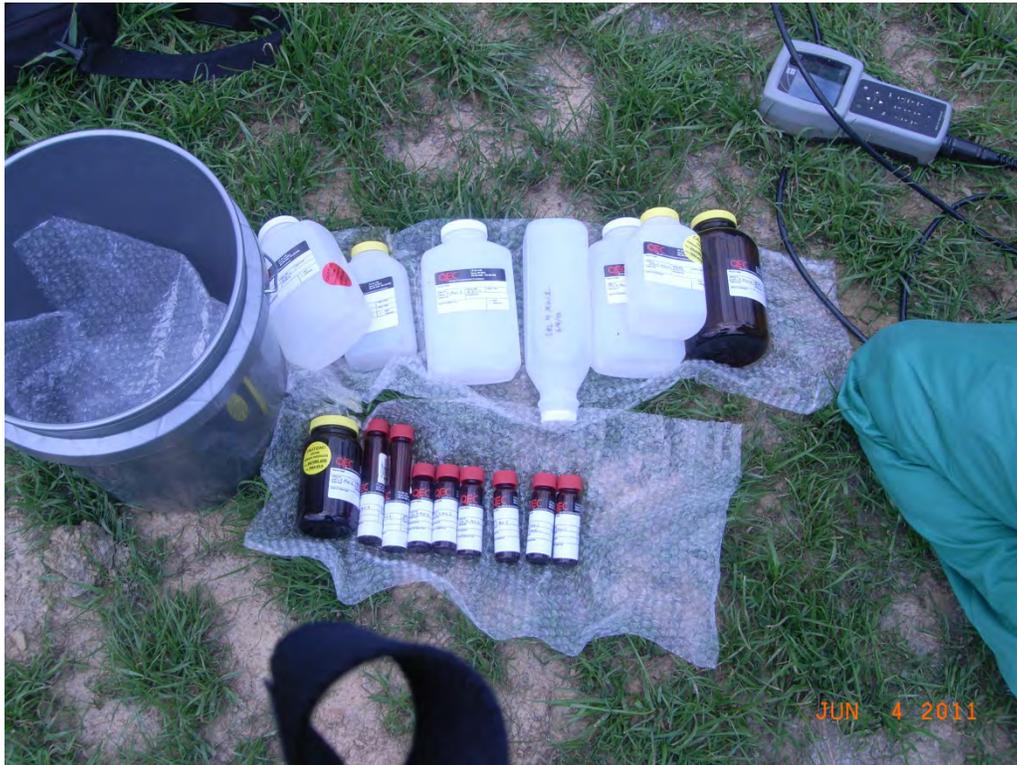
**Figure 18: Bottles for Typical Groundwater Sample**

Various sampling bottles needed for groundwater sampling collection are shown in **Figure 18**. Sample collection is illustrated in **Figure 19**. Groundwater monitoring well equipment used for the low-flow sampling method (51) is shown in **Figure 20**.
